2015 FACILITY CONDITION SURVEY

Skagit Valley College

SURVEY CONDUCTED BY:
Steve Lewandowski
State Board for Community
and Technical Colleges

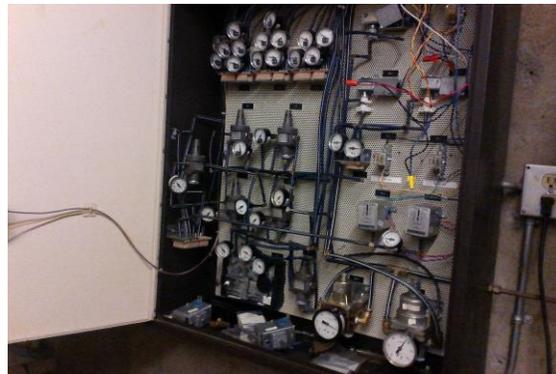
There are rotting pneumatic control tubing is rotten causing air leaks. The leaks are very difficult to locate and fix within walls. The college has had to tear open some walls to make repairs. The control system should be replaced.

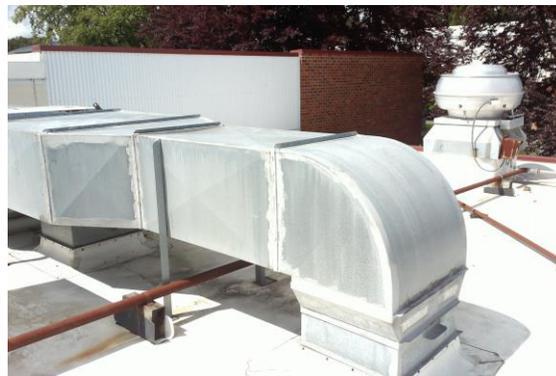
Deficiency F02

The kitchen makeup air and exhaust units fail frequently and require repairs to maintain the program. The units should be replaced.

Scoring priority category 2 : Facility Use
Category 2 percentage : 30 %
Project construction estimate (MACC): \$35,000
Total repair estimate (including soft costs): \$49,000
Deficiency score : 66

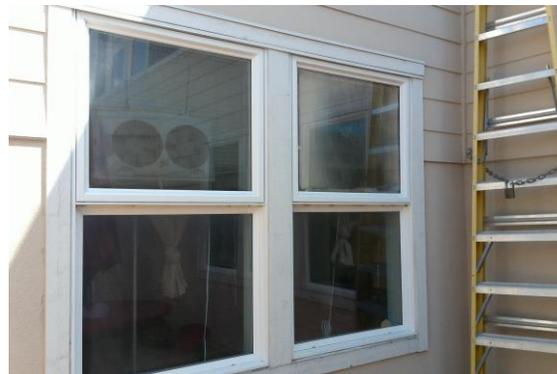
Deficiency F03

The window seals have failed. Windows are not under warranty because the manufacturer is no longer in business. The windows should be replaced.

Category 1 percentage : 80 %
Scoring priority category 2 : System Use
Category 2 percentage : 20 %
Project construction estimate (MACC): \$21,000
Total repair estimate (including soft costs): \$29,000
Deficiency score : 50

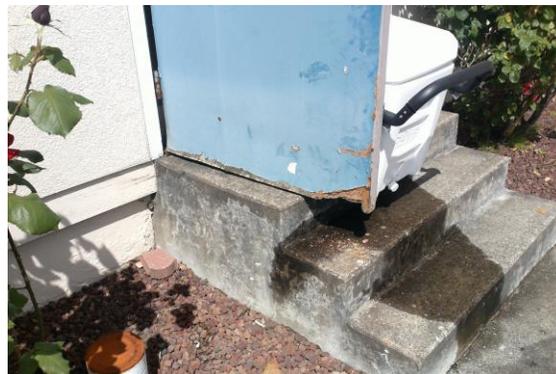
Deficiency F04

The doors have rotted out at the bottoms and should be replaced. The deck and soffits have also rotted out. The deck surface and soffit should be replaced.

Category 1 percentage : 60 %
Scoring priority category 2 : High Repair/Repl. Cost
Category 2 percentage : 40 %
Project construction estimate (MACC): \$24,000
Total repair estimate (including soft costs): \$33,000
Deficiency score : 55

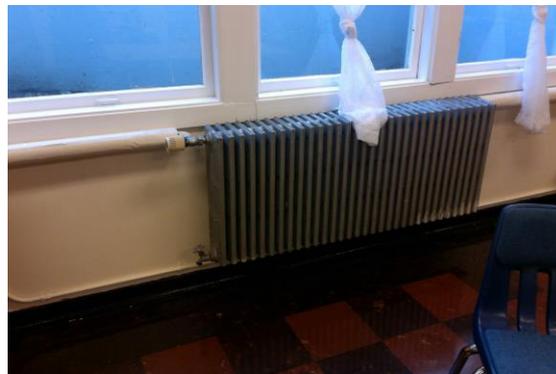
Deficiency F05

The old pipes have become clogged and no longer allow hot water to flow to the heaters. The heaters no longer function. The clogged pipes and non-functioning heaters should be replaced.

Category 1 percentage : 70 %
Scoring priority category 2 : High Repair/Repl. Cost
Category 2 percentage : 30 %
Project construction estimate (MACC): \$450,000
Total repair estimate (including soft costs): \$634,000
Deficiency score : 70

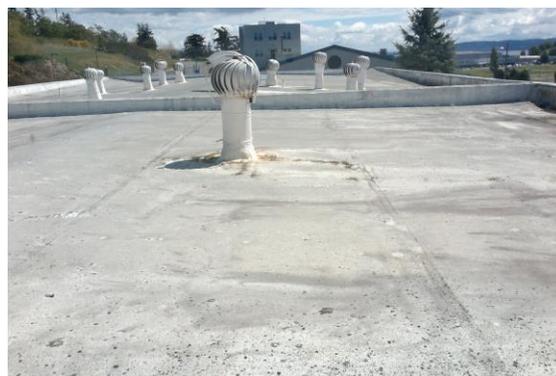
Deficiency R01

There are leaks in multiple locations allowing water to infiltrate the building envelope and cause damage. The roofing should be replaced, however the college would like to replace the building. Therefore the roof should be repaired using an elastomeric or silicon based product. The envelope damage due to leaks should also be repaired.

Recommended funding schedule : Immediate
Estimated remaining life (years) : 3
Estimated average life expectancy (years) : 25
Scoring priority category 1 : High Repair/Repl. Cost
Category 1 percentage : 70 %
Scoring priority category 2 : Facility Use
Category 2 percentage : 30 %
Project construction estimate (MACC): \$320,000
Total repair estimate (including soft costs): \$450,000
Deficiency score : 58

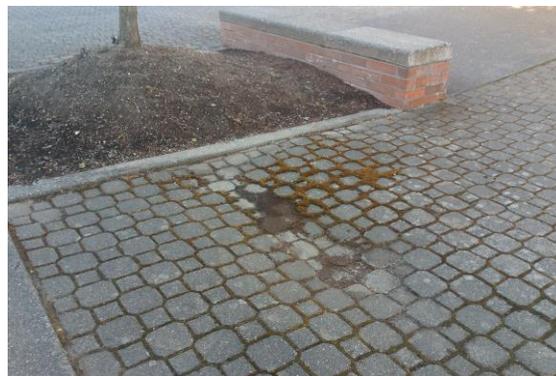
Deficiency S01

Pavers are a constant maintenance problem because of settling. They constantly need to be repaired to prevent trip hazards. The college has had preliminary steps towards a lawsuit in the past. The pavers should be replaced. A project with a cost below \$25,000 is considered maintenance.

Estimated average life expectancy (years) : 20
Scoring priority category 1 : High Repair/Repl. Cost
Category 1 percentage : 70 %
Scoring priority category 2 : Quality of Use
Category 2 percentage : 30 %
Project construction estimate (MACC): \$240,000
Total repair estimate (including soft costs): \$338,000
Deficiency score : 40
