2015 FACILITY CONDITION SURVEY

Skagit Valley College

SURVEY CONDUCTED BY:
Steve Lewandowski
State Board for Community
and Technical Colleges

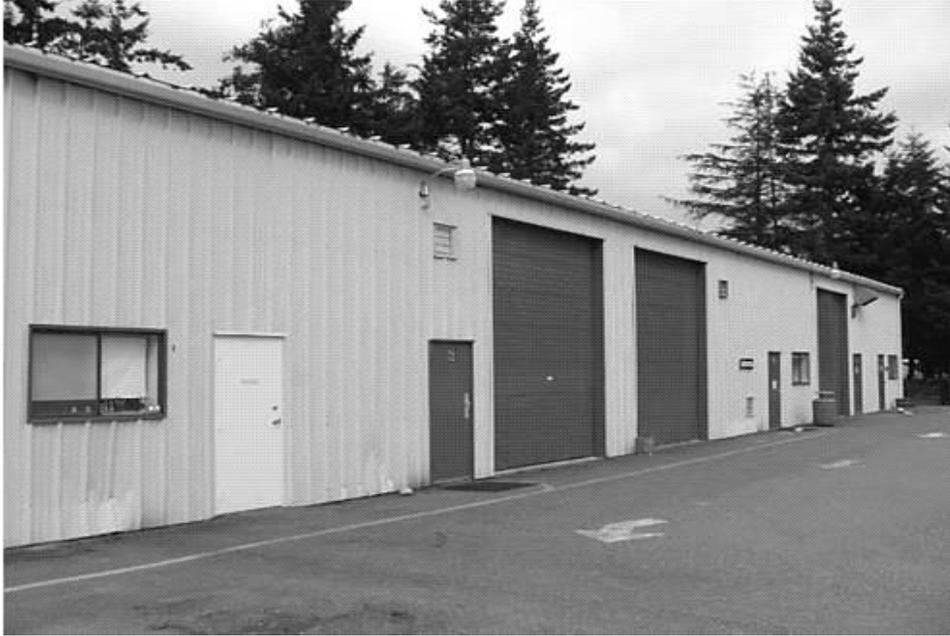
Whidbey Eceap (040-17) STATE UFI: A08585 Graphic Arts Site (040F)
 AREA: 8,000 SF BUILT: 1905 REMODELED: 2005 PREDOMINANT USE: Child/Parent Ed
 CONSTRUCTION TYPE: Medium CRV/SF: \$211 REPLACEMENT VALUE: \$1,688,000

Primary Systems	
COMPONENT: Structure	RATING: 1 x WEIGHT: 8.3 = SCORE: 8.3
No signs of settlement or cracking, no abrupt vertical changes Columns, bearing walls and roof structure appears sound/free of defects	
COMMENTS: Engineered metal building system; steel framing	
COMPONENT: Exterior Closure	RATING: 3 x WEIGHT: 8.3 = SCORE: 25
Sound and weatherproof but with some deterioration evident	
COMMENTS: Corrugated metal panels-random dents	
COMPONENT: Roofing	RATING: 1 x WEIGHT: 10.4 = SCORE: 10.4
Flashing and penetrations appear sound and membrane appears water- tight; drainage is positive and there are overflow scuppers	
COMMENTS: Corrugated metal panels-2005

Secondary Systems		
COMPONENT:	Floor Finishes	RATING: 3 x WEIGHT: 6.3 = SCORE: 18.8
Some wear and minor imperfections are evident; beginning deterioration		
COMMENTS:	Concrete; vinyl tile; wood parquet; carpet-surface wear	
COMPONENT:	Wall Finishes	RATING: 3 x WEIGHT: 6.3 = SCORE: 18.8
Aging surfaces but sound; some maintenance is required		
COMMENTS:	Gypsum board-dinged/marred	
COMPONENT:	Ceiling Finishes	RATING: 3 x WEIGHT: 6.3 = SCORE: 18.8
Some wear and tear; Minor staining or deterioration		
COMMENTS:	Lay-in tile; gypsum board; exposed structure; encapsulated insulation	
COMPONENT:	Doors & Hardware	RATING: 3 x WEIGHT: 6.3 = SCORE: 18.8
Functional but dated		
COMMENTS:	Interior wood/HM doors/frames-surface wear; exterior HM doors/frames-surface wear; OH metal doors/frames

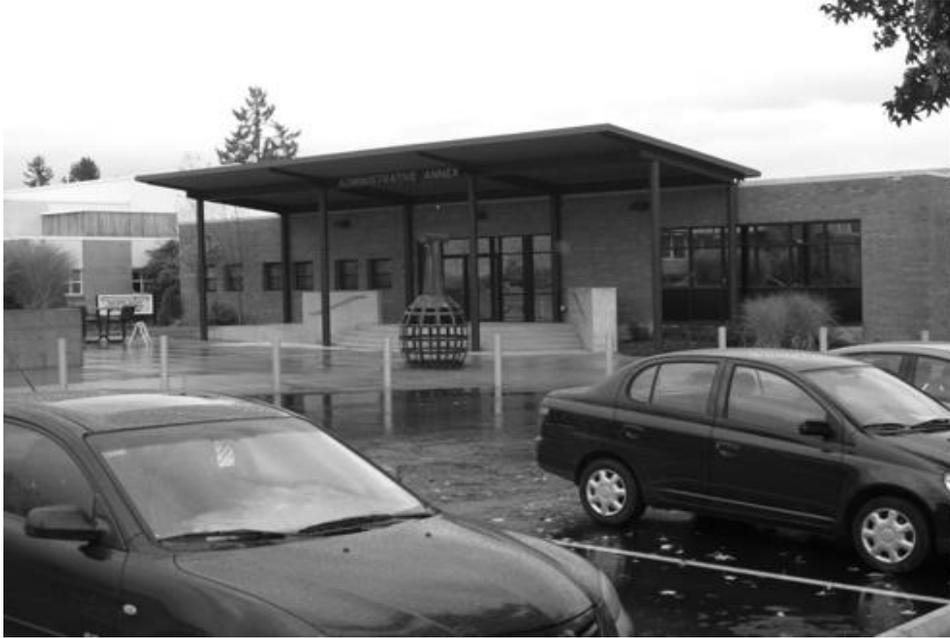
Administrative Annex (040-37) STATE UFI: A00766 Main Campus (040A)
 AREA: 16,519 SF BUILT: 1986 REMODELED: 2008 PREDOMINANT USE: Administration
 CONSTRUCTION TYPE: Medium CRV/SF: \$269 REPLACEMENT VALUE: \$4,443,611

Primary Systems	
COMPONENT: Structure	RATING: 1 x WEIGHT: 8.3 = SCORE: 8.3
No signs of settlement or cracking, no abrupt vertical changes Columns, bearing walls and roof structure appears sound/free of defects	
COMMENTS: Wood frame & trusses; glu-lam beams	
COMPONENT: Exterior Closure	RATING: 1 x WEIGHT: 8.3 = SCORE: 8.3
Weatherproof, tight, well-maintained exterior walls, doors, windows/finishes	
COMMENTS: Brick veneer; EIFS; stucco; corrugated metal panels; concrete	
COMPONENT: Roofing	RATING: 1 x WEIGHT: 10.4 = SCORE: 10.4
Flashing and penetrations appear sound and membrane appears water- tight; drainage is positive and there are overflow scuppers	
COMMENTS: TPO single-ply membrane; replaced in 2013

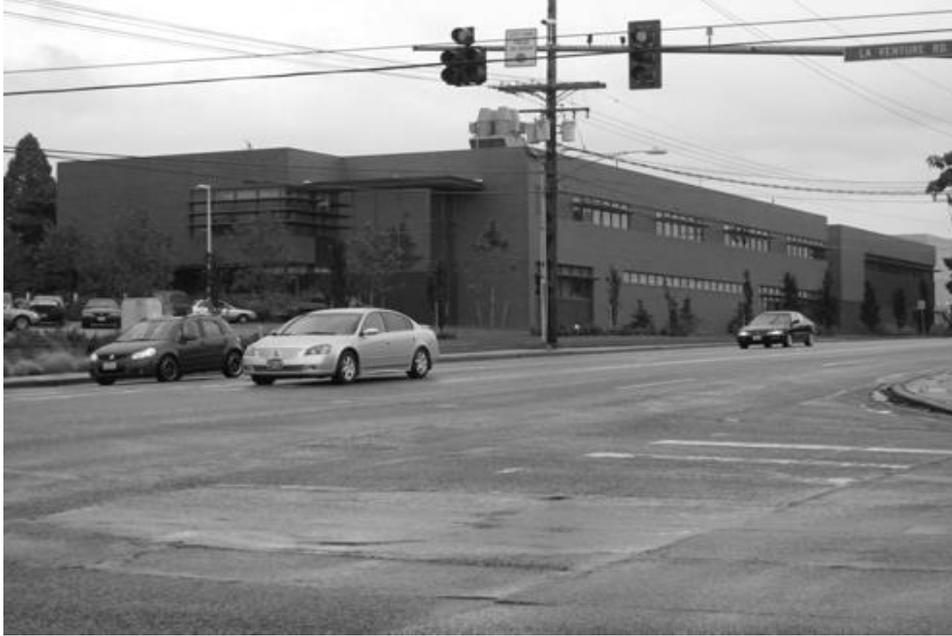
Angst Hall (040-55) STATE UFI: A06053 Main Campus (040A)
 AREA: 67,942 SF BUILT: 2009 REMODELED: No PREDOMINANT USE: Science Lab.
 CONSTRUCTION TYPE: Heavy CRV/SF: \$391 REPLACEMENT VALUE: \$26,565,322

Primary Systems	
COMPONENT: Structure	RATING: 1 x WEIGHT: 8 = SCORE: 8
No signs of settlement or cracking, no abrupt vertical changes Columns, bearing walls and roof structure appears sound/free of defects	
COMMENTS:	Structural steel; concrete; brick
COMPONENT: Exterior Closure	RATING: 1 x WEIGHT: 8 = SCORE: 8
Weatherproof, tight, well-maintained exterior walls, doors, windows/finishes	
COMMENTS:	Brick; steel sun shades; aluminum window walls; plexiglass panels
COMPONENT: Roofing	RATING: 1 x WEIGHT: 10 = SCORE: 10
Flashing and penetrations appear sound and membrane appears water- tight; drainage is positive and there are overflow scuppers	
COMMENTS:	Single-ply TPO membrane; skylights

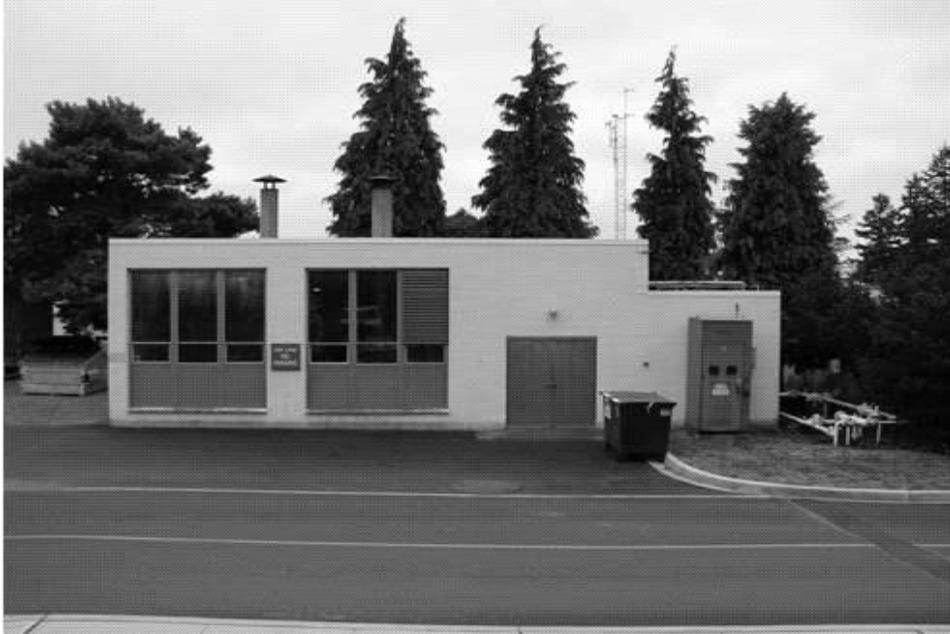
Boiler (040-20) STATE UFI: A01655 Main Campus (040A)
 AREA: 1,443 SF BUILT: 1959 REMODELED: No PREDOMINANT USE: Utility
 CONSTRUCTION TYPE: Heavy CRV/SF: \$264 REPLACEMENT VALUE: \$380,952

Primary Systems	
COMPONENT: Structure	RATING: 1 x WEIGHT: 9.1 = SCORE: 9.1
No signs of settlement or cracking, no abrupt vertical changes Columns, bearing walls and roof structure appears sound/free of defects	
COMMENTS: CMU walls, concrete roof	
COMPONENT: Exterior Closure	RATING: 1 x WEIGHT: 9.1 = SCORE: 9.1
Weatherproof, tight, well-maintained exterior walls, doors, windows/finishes	
COMMENTS: CMU	
COMPONENT: Roofing	RATING: 1 x WEIGHT: 11.4 = SCORE: 11.4
Flashing and penetrations appear sound and membrane appears water- tight; drainage is positive and there are overflow scuppers	
COMMENTS: Single ply hypalon membrane

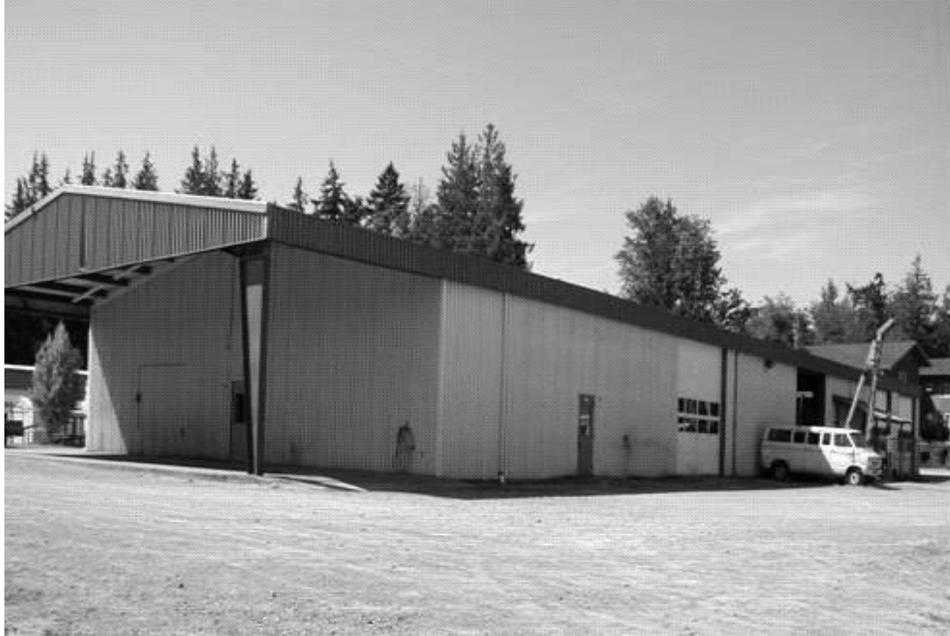
Diesel Building (040-86) STATE UFI: A08595 Main Campus (040A)
 AREA: 10,900 SF BUILT: 1982 REMODELED: No PREDOMINANT USE: Vocational Arts
 CONSTRUCTION TYPE: Heavy CRV/SF: \$3159 REPLACEMENT VALUE: \$34,433,100

Primary Systems	
COMPONENT: Structure	RATING: 1 x WEIGHT: 8.3 = SCORE: 8.3
No signs of settlement or cracking, no abrupt vertical changes Columns, bearing walls and roof structure appears sound/free of defects	
COMMENTS: Steel frame	
COMPONENT: Exterior Closure	RATING: 3 x WEIGHT: 8.3 = SCORE: 25
Sound and weatherproof but with some deterioration evident	
COMMENTS: Metal corrugated panels	
COMPONENT: Roofing	RATING: 1 x WEIGHT: 10.4 = SCORE: 10.4
Flashing and penetrations appear sound and membrane appears water- tight; drainage is positive and there are overflow scuppers	
COMMENTS: Metal roof-2008

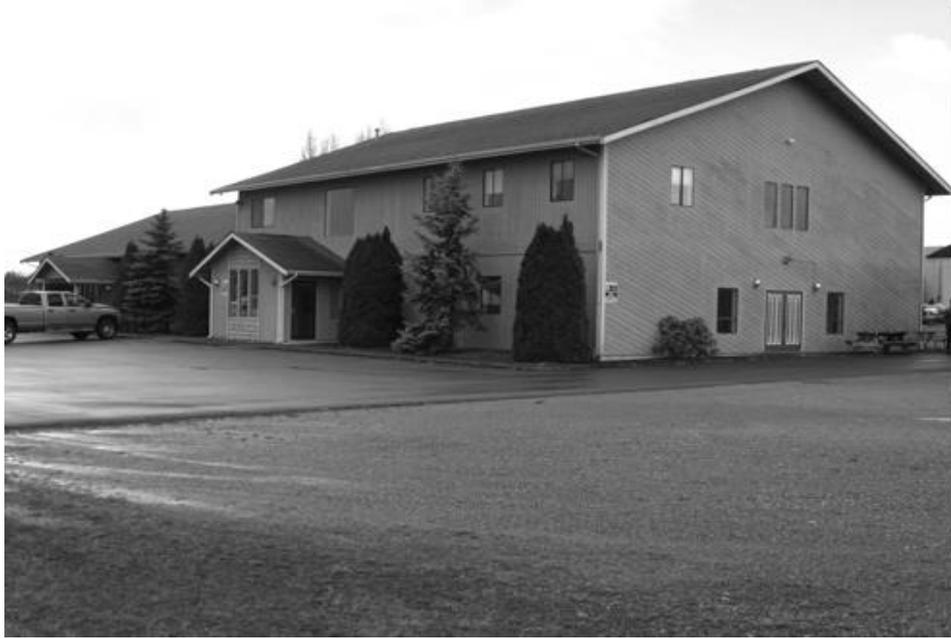
East Campus Building (040-92) STATE UFI: A06954 Main Campus (040A)
 AREA: 10,250 SF BUILT: 1905 REMODELED: No PREDOMINANT USE: Vacant
 CONSTRUCTION TYPE: Light CRV/SF: \$185 REPLACEMENT VALUE: \$1,896,250

Primary Systems	
COMPONENT: Structure	RATING: 1 x WEIGHT: 8 = SCORE: 8
No signs of settlement or cracking, no abrupt vertical changes Columns, bearing walls and roof structure appears sound/free of defects	
COMMENTS: wood frame	
COMPONENT: Exterior Closure	RATING: 1 x WEIGHT: 8 = SCORE: 8
Weatherproof, tight, well-maintained exterior walls, doors, windows/finishes	
COMMENTS: Vertical wood siding; cedar shingles	
COMPONENT: Roofing	RATING: 1 x WEIGHT: 10 = SCORE: 10
Flashing and penetrations appear sound and membrane appears water- tight; drainage is positive and there are overflow scuppers	
COMMENTS: New composition asphalt shingle roof 2011-13

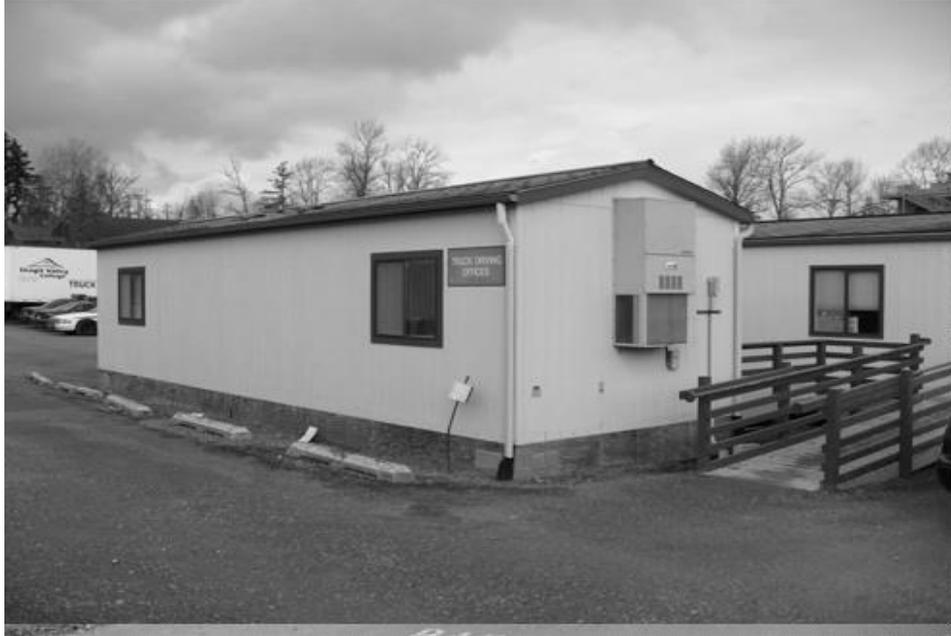
Fire Fighting Storage (040-88) STATE UFI: A04018 Main Campus (040A)
 AREA: 480 SF BUILT: 1995 REMODELED: No PREDOMINANT USE: Administration
 CONSTRUCTION TYPE: Light CRV/SF: \$106 REPLACEMENT VALUE: \$50,880

Primary Systems	
COMPONENT: Structure	RATING: 3 x WEIGHT: 8.3 = SCORE: 25
Some cracking evident but does not likely affect structural integrity; Visible defects apparent but are non-structural	
COMMENTS: wood frame	
COMPONENT: Exterior Closure	RATING: 5 x WEIGHT: 8.3 = SCORE: 41.7
Significant deterioration, leaking and air infiltration apparent	
COMMENTS: T1-11 wood panels	
COMPONENT: Roofing	RATING: 3 x WEIGHT: 10.4 = SCORE: 31.3
Some deterioration is evident in membrane and flashings; maintenance or minor repair is needed	
COMMENTS: Composition shingle

Secondary Systems			
COMPONENT:	Floor Finishes	RATING: 5 x WEIGHT: 6.3 =	SCORE: 31.3
	Extensive deterioration and unevenness		
COMMENTS:	Vinyl tile and sheet vinyl		
COMPONENT:	Wall Finishes	RATING: 3 x WEIGHT: 6.3 =	SCORE: 18.8
	Aging surfaces but sound; some maintenance is required		
COMMENTS:	Vinyl clad gypsum board		
COMPONENT:	Ceiling Finishes	RATING: 3 x WEIGHT: 6.3 =	SCORE: 18.8
	Some wear and tear; Minor staining or deterioration		
COMMENTS:	Lay-in tile		
COMPONENT:	Doors & Hardware	RATING: 3 x WEIGHT: 6.3 =	SCORE: 18.8
	Functional but dated		
COMMENTS:	HM doors and frames

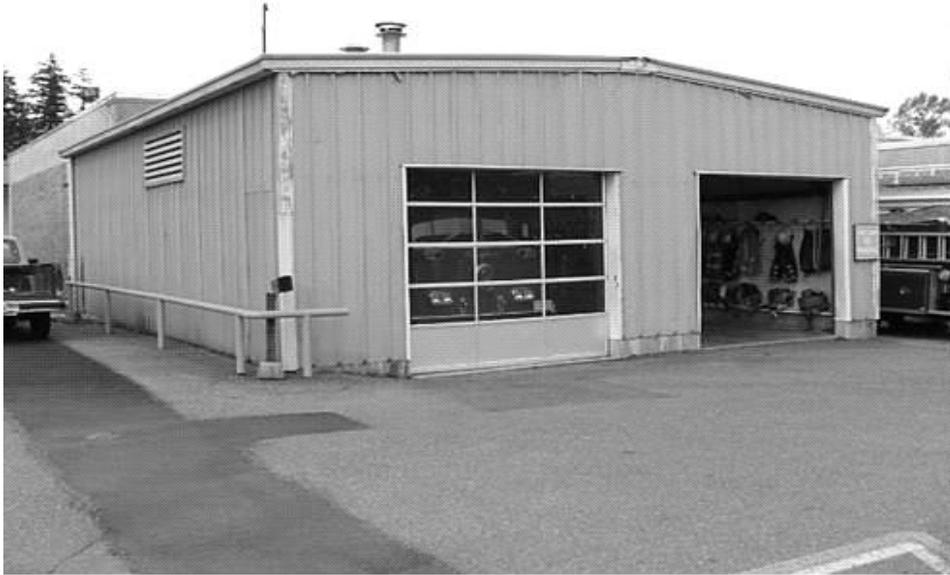
Fire Station (040-81) STATE UFI: A03657 Main Campus (040A)
 AREA: 2,400 SF BUILT: 1973 REMODELED: No PREDOMINANT USE: Storage
 CONSTRUCTION TYPE: Light CRV/SF: \$158 REPLACEMENT VALUE: \$379,200

Primary Systems	
COMPONENT: Structure	RATING: 1 x WEIGHT: 9.1 = SCORE: 9.1
No signs of settlement or cracking, no abrupt vertical changes Columns, bearing walls and roof structure appears sound/free of defects	
COMMENTS: Steel frame	
COMPONENT: Exterior Closure	RATING: 1 x WEIGHT: 9.1 = SCORE: 9.1
Weatherproof, tight, well-maintained exterior walls, doors, windows/finishes	
COMMENTS: Metal corrugated panels	
COMPONENT: Roofing	RATING: 3 x WEIGHT: 11.4 = SCORE: 34.2
Some deterioration is evident in membrane and flashings; maintenance or minor repair is needed	
COMMENTS: Metal corrugated panels

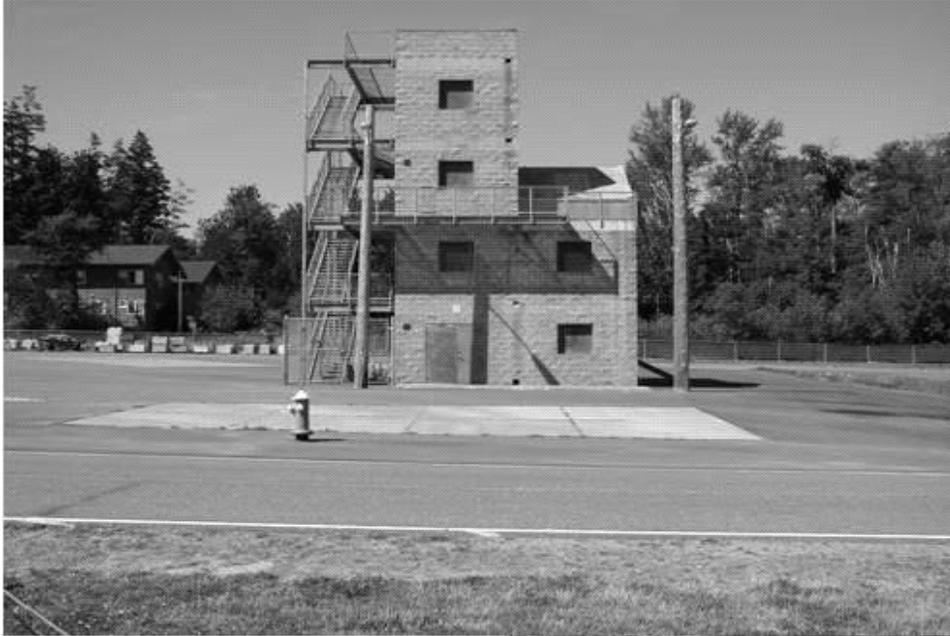
Fire Training Tower (040-71) STATE UFI: A08310 Main Campus (040A)
 AREA: 5,100 SF BUILT: 1998 REMODELED: No PREDOMINANT USE: Training
 CONSTRUCTION TYPE: Medium CRV/SF: \$158 REPLACEMENT VALUE: \$805,800

Primary Systems	
COMPONENT: Structure	RATING: 1 x WEIGHT: 13 = SCORE: 13
No signs of settlement or cracking, no abrupt vertical changes Columns, bearing walls and roof structure appears sound/free of defects	
COMMENTS: CMU, concrete; steel exterior staircase	
COMPONENT: Exterior Closure	RATING: 1 x WEIGHT: 13 = SCORE: 13
Weatherproof, tight, well-maintained exterior walls, doors, windows/finishes	
COMMENTS: CMU	
COMPONENT: Roofing	RATING: 3 x WEIGHT: 16.2 = SCORE: 48.7
Some deterioration is evident in membrane and flashings; maintenance or minor repair is needed	
COMMENTS: Concrete; plywood for training area

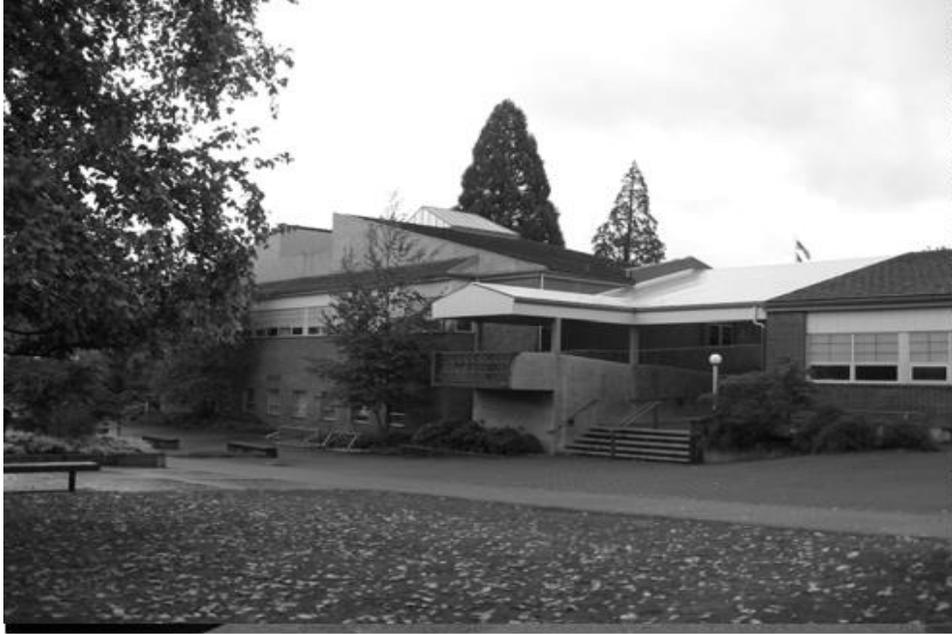
Ford Hall (040-54) STATE UFI: A05075 Main Campus (040A)
 AREA: 23,600 SF BUILT: 1988 REMODELED: No PREDOMINANT USE: Computer Lab.
 CONSTRUCTION TYPE: Medium CRV/SF: \$301 REPLACEMENT VALUE: \$7,103,600

Primary Systems	
COMPONENT: Structure	RATING: 1 x WEIGHT: 8 = SCORE: 8
No signs of settlement or cracking, no abrupt vertical changes Columns, bearing walls and roof structure appears sound/free of defects	
COMMENTS: Wood frame and trusses; concrete; glu-lam framed breezeway between buildings	
COMPONENT: Exterior Closure	RATING: 1 x WEIGHT: 8 = SCORE: 8
Weatherproof, tight, well-maintained exterior walls, doors, windows/finishes	
COMMENTS: Brick veneer; stucco	
COMPONENT: Roofing	RATING: 1 x WEIGHT: 10 = SCORE: 10
Flashing and penetrations appear sound and membrane appears water- tight; drainage is positive and there are overflow scuppers	
COMMENTS: Cement tile; corrugated lexan panels; skylight over light well/atrium

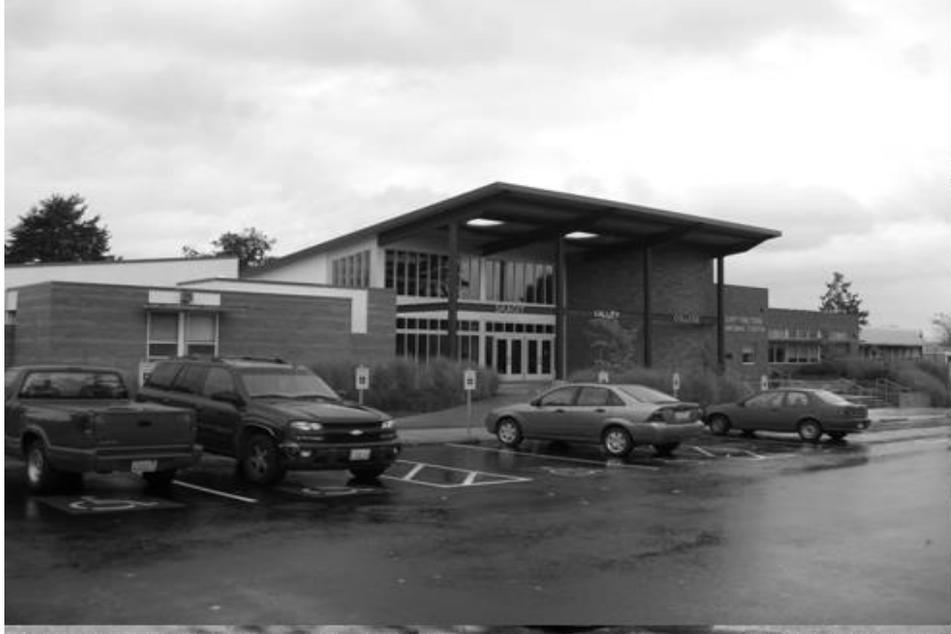
Gary Knutzen Cardinal Center (040-30) STATE UFI: A09143 Main Campus (040A)
 AREA: 27,558 SF BUILT: 1959 REMODELED: 2005 PREDOMINANT USE: Student Center
 CONSTRUCTION TYPE: Medium CRV/SF: \$313 REPLACEMENT VALUE: \$8,625,654

Primary Systems	
COMPONENT: Structure	RATING: 1 x WEIGHT: 8.3 = SCORE: 8.3
No signs of settlement or cracking, no abrupt vertical changes Columns, bearing walls and roof structure appears sound/free of defects	
COMMENTS: Steel; wood framing	
COMPONENT: Exterior Closure	RATING: 1 x WEIGHT: 8.3 = SCORE: 8.3
Weatherproof, tight, well-maintained exterior walls, doors, windows/finishes	
COMMENTS: Brick; stucco; concrete	
COMPONENT: Roofing	RATING: 3 x WEIGHT: 10.4 = SCORE: 31.3
Some deterioration is evident in membrane and flashings; maintenance or minor repair is needed	
COMMENTS: New single-ply PVC roof in Kitchen and Counseling areas funded in current biennium

Secondary Systems			
COMPONENT:	Floor Finishes	RATING: 1 x	WEIGHT: 6.3 = SCORE: 6.3
Nice appearance, smooth transitions, level subfloors, no cracks/separating			
COMMENTS:	Carpet; vinyl asbestos and composition tile; concrete; ceramic tile; sheet vinyl-some wear		
COMPONENT:	Wall Finishes	RATING: 1 x	WEIGHT: 6.3 = SCORE: 6.3
Maintainable surfaces in good condition			
COMMENTS:	Gypsum board, brick, ceramic tile; moveable partition walls		
COMPONENT:	Ceiling Finishes	RATING: 1 x	WEIGHT: 6.3 = SCORE: 6.3
Maintainable surfaces in good condition; good alignment and appearance			
COMMENTS:	Gypsum board; lay-in tile; wood decking; metal deck pan		
COMPONENT:	Doors & Hardware	RATING: 3 x	WEIGHT: 6.3 = SCORE: 18.8
Functional but dated			
COMMENTS:	Interior wood doors w HM frames-significant surface wear; exterior HM doors/frames; aluminum doors/frames; window wall

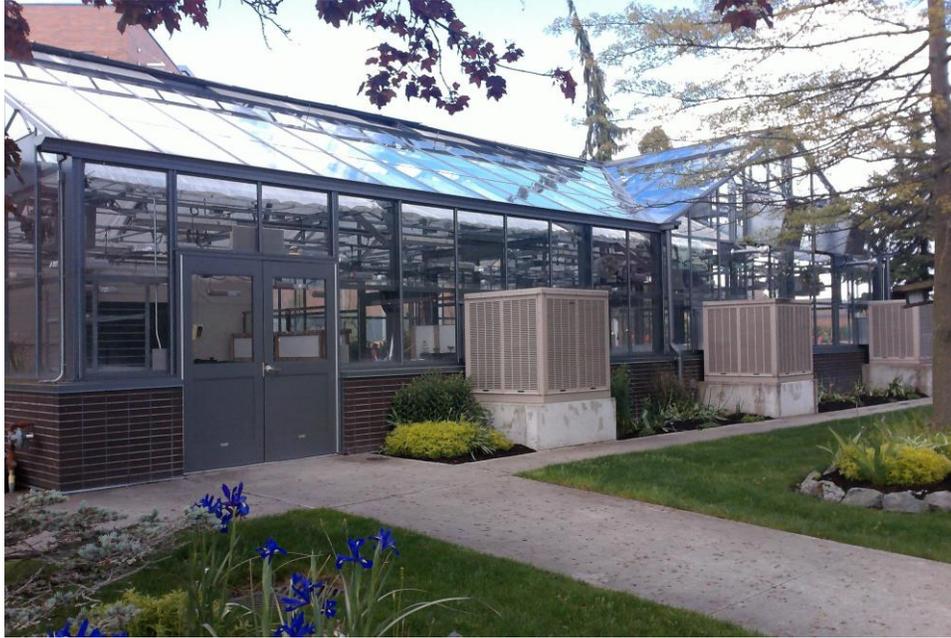
Greenhouse (040-99) STATE UFI: A10392 Main Campus (040A)
 AREA: 2,628 SF BUILT: 2010 REMODELED: No PREDOMINANT USE: Other (All Purpose)
 #VALUE!

Primary Systems	
COMPONENT: Structure	RATING: 1 x WEIGHT: 9.1 = SCORE: 9.1
No signs of settlement or cracking, no abrupt vertical changes Columns, bearing walls and roof structure appears sound/free of defects	
COMMENTS: Steel framing	
COMPONENT: Exterior Closure	RATING: 1 x WEIGHT: 9.1 = SCORE: 9.1
Weatherproof, tight, well-maintained exterior walls, doors, windows/finishes	
COMMENTS: Glass; brick	
COMPONENT: Roofing	RATING: 1 x WEIGHT: 11.4 = SCORE: 11.4
Flashing and penetrations appear sound and membrane appears water- tight; drainage is positive and there are overflow scuppers	
COMMENTS: Glass

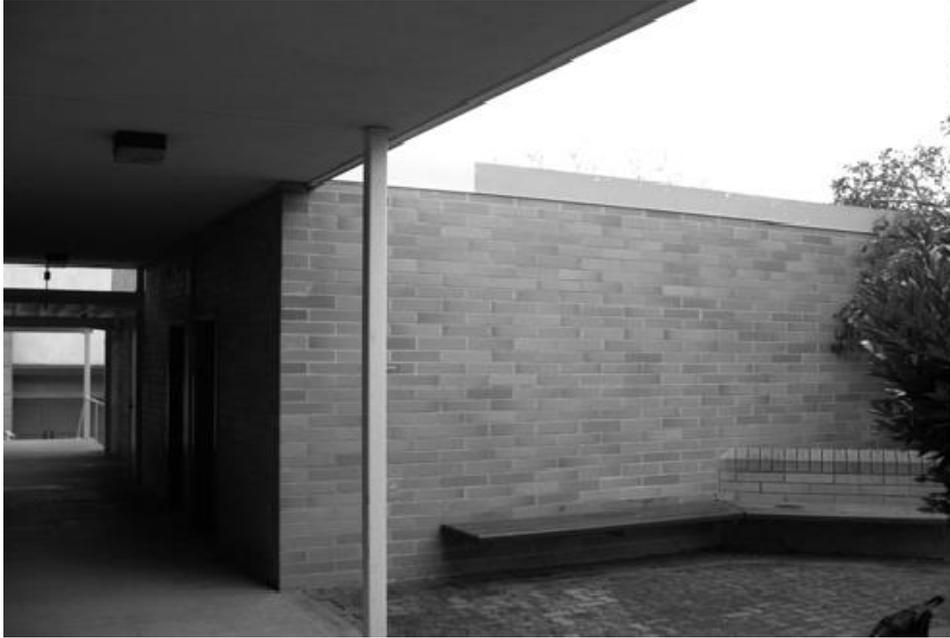
Hodson Exterior Restroom (040-41) STATE UFI: A03904 Main Campus (040A)
 AREA: 473 SF BUILT: 1980 REMODELED: No PREDOMINANT USE: Rest Room
 CONSTRUCTION TYPE: Medium CRV/SF: \$158 REPLACEMENT VALUE: \$74,734

Primary Systems	
COMPONENT: Structure	RATING: 1 x WEIGHT: 8.7 = SCORE: 8.7
No signs of settlement or cracking, no abrupt vertical changes Columns, bearing walls and roof structure appears sound/free of defects	
COMMENTS:	Brick w wood roof framing
COMPONENT: Exterior Closure	RATING: 1 x WEIGHT: 8.7 = SCORE: 8.7
Weatherproof, tight, well-maintained exterior walls, doors, windows/finishes	
COMMENTS:	Brick
COMPONENT: Roofing	RATING: 3 x WEIGHT: 10.9 = SCORE: 32.7
Some deterioration is evident in membrane and flashings; maintenance or minor repair is needed	
COMMENTS:	PVC single-ply roof

Secondary Systems			
COMPONENT:	Floor Finishes	RATING: 1 x WEIGHT: 6.5 =	SCORE: 6.5
	Nice appearance, smooth transitions, level subfloors, no cracks/separating		
COMMENTS:	Concrete floor w epoxy coating		
COMPONENT:	Wall Finishes	RATING: 1 x WEIGHT: 6.5 =	SCORE: 6.5
	Maintainable surfaces in good condition		
COMMENTS:	Brick and tile		
COMPONENT:	Ceiling Finishes	RATING: 3 x WEIGHT: 6.5 =	SCORE: 19.6
	Some wear and tear; Minor staining or deterioration		
COMMENTS:	Lay-in tile		
COMPONENT:	Doors & Hardware	RATING: 3 x WEIGHT: 6.5 =	SCORE: 19.6
	Functional but dated		
COMMENTS:	Wood doors and frames

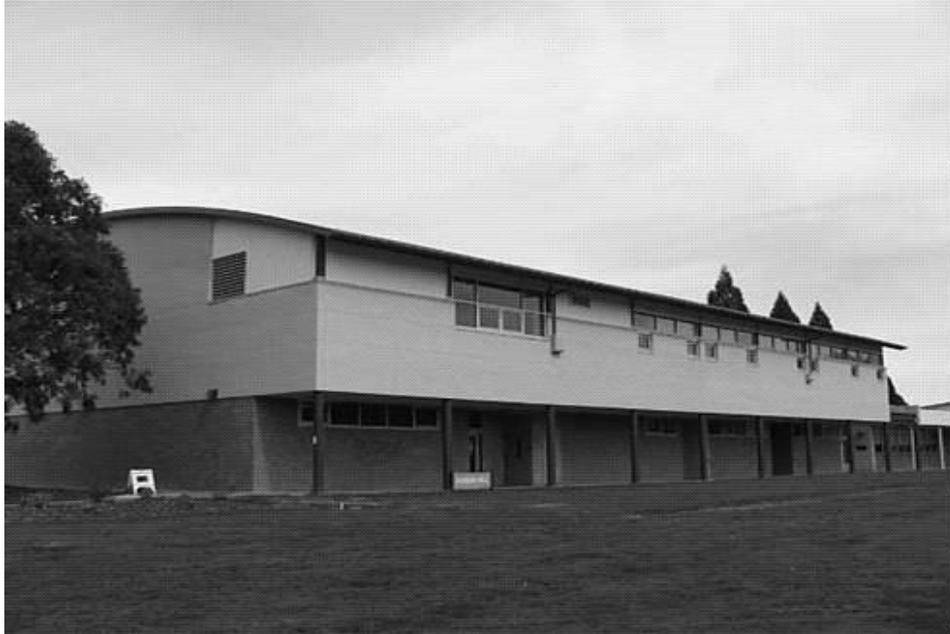
Hodson Hall (040-40) STATE UFI: A09436 Main Campus (040A)
 AREA: 30,346 SF BUILT: 1959 REMODELED: 2009 PREDOMINANT USE: Visual Arts
 CONSTRUCTION TYPE: Medium CRV/SF: \$337 REPLACEMENT VALUE: \$10,226,602

Primary Systems	
COMPONENT: Structure	RATING: 1 x WEIGHT: 8 = SCORE: 8
No signs of settlement or cracking, no abrupt vertical changes Columns, bearing walls and roof structure appears sound/free of defects	
COMMENTS: Steel framed original building and second story addition; steel columns; wood framing	
COMPONENT: Exterior Closure	RATING: 1 x WEIGHT: 8 = SCORE: 8
Weatherproof, tight, well-maintained exterior walls, doors, windows/finishes	
COMMENTS: Brick; stucco; metal fascia; corrugated metal siding - good condition	
COMPONENT: Roofing	RATING: 1 x WEIGHT: 10 = SCORE: 10
Flashing and penetrations appear sound and membrane appears water- tight; drainage is positive and there are overflow scuppers	
COMMENTS: Metal standing seam roof; hypalon single-ply roof

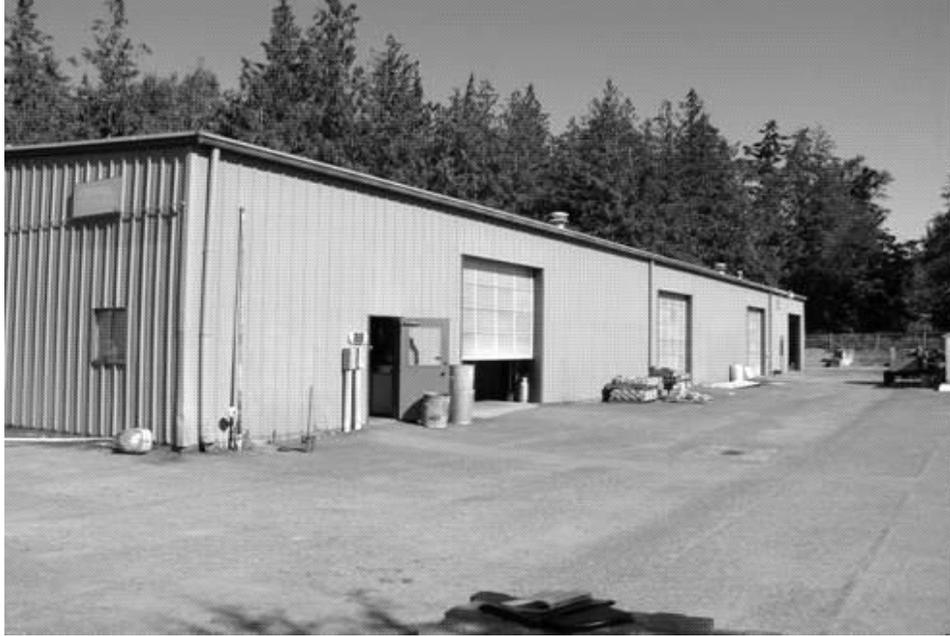
Maintenance Bldg (040-21) STATE UFI: A07870 Main Campus (040A)
 AREA: 4,800 SF BUILT: 1976 REMODELED: No PREDOMINANT USE: Maintenance
 CONSTRUCTION TYPE: Medium CRV/SF: \$211 REPLACEMENT VALUE: \$1,012,800

Primary Systems	
COMPONENT: Structure	RATING: 1 x WEIGHT: 8.7 = SCORE: 8.7
No signs of settlement or cracking, no abrupt vertical changes Columns, bearing walls and roof structure appears sound/free of defects	
COMMENTS: Steel frame	
COMPONENT: Exterior Closure	RATING: 3 x WEIGHT: 8.7 = SCORE: 26.1
Sound and weatherproof but with some deterioration evident	
COMMENTS: Metal panels-random damage	
COMPONENT: Roofing	RATING: 3 x WEIGHT: 10.9 = SCORE: 32.7
Some deterioration is evident in membrane and flashings; maintenance or minor repair is needed	
COMMENTS: Deteriorating metal roof and gutters; new roof funded in 2007; will not be done

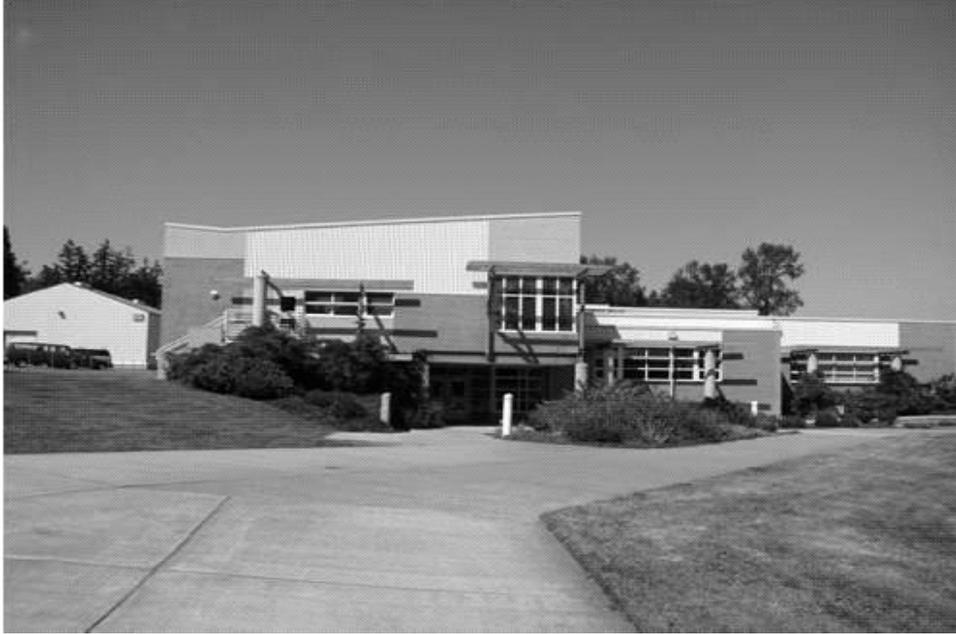
Nelson Hall (040-82) STATE UFI: A07932 Main Campus (040A)
 AREA: 13,055 SF BUILT: 1996 REMODELED: No PREDOMINANT USE: General Classroom
 CONSTRUCTION TYPE: Medium CRV/SF: \$301 REPLACEMENT VALUE: \$3,929,555

Primary Systems	
COMPONENT: Structure	RATING: 1 x WEIGHT: 8 = SCORE: 8
No signs of settlement or cracking, no abrupt vertical changes Columns, bearing walls and roof structure appears sound/free of defects	
COMMENTS: Wood frame and concrete	
COMPONENT: Exterior Closure	RATING: 1 x WEIGHT: 8 = SCORE: 8
Weatherproof, tight, well-maintained exterior walls, doors, windows/finishes	
COMMENTS: Brick veneer; corrugated metal siding; stucco	
COMPONENT: Roofing	RATING: 1 x WEIGHT: 10 = SCORE: 10
Flashing and penetrations appear sound and membrane appears water- tight; drainage is positive and there are overflow scuppers	
COMMENTS: Hypalon single ply membrane

COMPONENT:	Floor Finishes	RATING: 1	x	WEIGHT: 6	=	SCORE: 6
	Nice appearance, smooth transitions, level subfloors, no cracks/separating					
COMMENTS:	Ceramic tile; rubber; carpet-random wear; vinyl tile					
COMPONENT:	Wall Finishes	RATING: 1	x	WEIGHT: 6	=	SCORE: 6
	Maintainable surfaces in good condition					
COMMENTS:	Gypsum board; concrete; ceramic tile					
COMPONENT:	Ceiling Finishes	RATING: 1	x	WEIGHT: 6	=	SCORE: 6
	Maintainable surfaces in good condition; good alignment and appearance					
COMMENTS:	Gypsum board; lay-in tile					
COMPONENT:	Doors & Hardware	RATING: 3	x	WEIGHT: 6	=	SCORE: 18
	Functional but dated					
COMMENTS:	Interior wood doors w HM frames; exterior HM doors/frames-worn

COMPONENT:	Elevators	RATING: 1	x	WEIGHT: 6	=	SCORE: 6
	Appropriate and functional for occupancy and use					
COMMENTS:	3 stop (2 story split level building)					
COMPONENT:	Plumbing	RATING: 1	x	WEIGHT: 8	=	SCORE: 8
	Fixtures and piping appear to be in good condition; no evidence of leaks					
COMMENTS:	Copper, cast iron, steel and ABS piping; porcelain fixtures					
COMPONENT:	HVAC	RATING: 1	x	WEIGHT: 8	=	SCORE: 8
	Equipment in good condition; easily controlled; serves all required spaces; All necessary spaces are adequately ventilated; A/C provided					
COMMENTS:	AHUs w VAVs; DX cooling; hydronic and steam heat from central plant					
COMPONENT:	Electrical	RATING: 1	x	WEIGHT: 8	=	SCORE: 8
	Adequate service and distribution capacity for current/future needs					
COMMENTS:	400amp 480/277v					
COMPONENT:	Lights/Power	RATING: 1	x	WEIGHT: 8	=	SCORE: 8
	Contemporary lighting with good work area illumination; ample outlets

Safety Systems			
COMPONENT:	Life/Safety	RATING: 1 x	WEIGHT: 10 = SCORE: 10
Appears to meet current codes			
COMMENTS:			
COMPONENT:	Fire Safety	RATING: 3 x	WEIGHT: 10 = SCORE: 30
Extinguishers and signed egress; no violations; no alarm or sprinklers			
COMMENTS:			
COMPONENT:	Modifications	RATING: 1 x	WEIGHT: 7 = SCORE: 7
Modifications appear to be in compliance with codes and sound construction practices; HVAC/electrical service properly provided			
COMMENTS:	No modifications to present

Quality Standards			
COMPONENT:	Maintenance	RATING: 1 x	WEIGHT: 7 = SCORE: 7
Facility appears well maintained			
COMMENTS:			
COMPONENT:	Remaining Life	RATING: 1 x	WEIGHT: 6 = SCORE: 6
Life expectancy is >15 years; minor system deterioration			
COMMENTS:	Relatively new facility		
COMPONENT:	Appearance	RATING: 1 x	WEIGHT: 6 = SCORE: 6
Well-constructed building; generally attractive interior and exterior			
COMMENTS:

TOTAL SCORE = 190 PREVIOUS BIENNIUM SCORE = 190
 CONDITION: Adequate

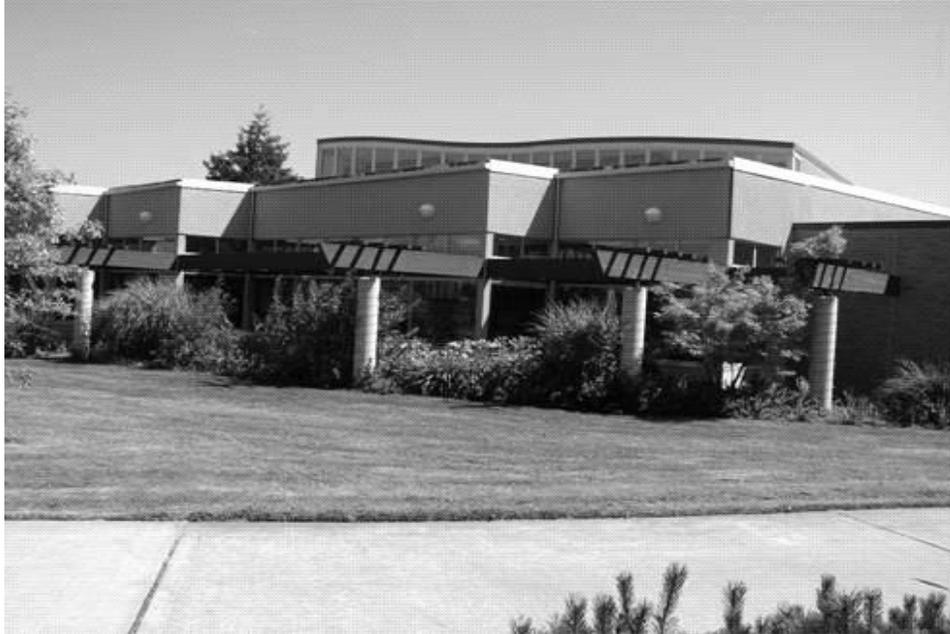
Norwood Cole Library (040-70) STATE UFI: A05680 Main Campus (040A)
 AREA: 26,730 SF BUILT: 1963 REMODELED: 1995 PREDOMINANT USE: Library
 CONSTRUCTION TYPE: Medium CRV/SF: \$301 REPLACEMENT VALUE: \$8,045,730

Primary Systems	
COMPONENT: Structure	RATING: 1 x WEIGHT: 8.3 = SCORE: 8.3
No signs of settlement or cracking, no abrupt vertical changes Columns, bearing walls and roof structure appears sound/free of defects	
COMMENTS: Steel columns and joists; concrete columns; steel beams; exterior wood trellis	
COMPONENT: Exterior Closure	RATING: 3 x WEIGHT: 8.3 = SCORE: 25
Sound and weatherproof but with some deterioration evident	
COMMENTS: Brick veneer; stucco; concrete; brick cracks in multiple areas; stucco deterioration at some corners	
COMPONENT: Roofing	RATING: 3 x WEIGHT: 10.4 = SCORE: 31.3
Some deterioration is evident in membrane and flashings; maintenance or minor repair is needed	
COMMENTS: TPO single-ply membrane; cap sheet BUR-edges at gutters need sealing; standing seam metal cap

Secondary Systems			
COMPONENT:	Floor Finishes	RATING: 3 x WEIGHT: 6.3 =	SCORE: 18.8
Some wear and minor imperfections are evident; beginning deterioration			
COMMENTS:	Vinyl tile; carpet; ceramic tile		
COMPONENT:	Wall Finishes	RATING: 1 x WEIGHT: 6.3 =	SCORE: 6.3
Maintainable surfaces in good condition			
COMMENTS:	Gypsum board; concrete; ceramic tile		
COMPONENT:	Ceiling Finishes	RATING: 3 x WEIGHT: 6.3 =	SCORE: 18.8
Some wear and tear; Minor staining or deterioration			
COMMENTS:	Gypsum board; lay-in tile; vent wood; direct-adhered tile		
COMPONENT:	Doors & Hardware	RATING: 1 x WEIGHT: 6.3 =	SCORE: 6.3
Appropriate hardware, closers, panic devices; in good working order			
COMMENTS:	Interior wood doors w HM frames; exterior HM and aluminum doors/frames

Service Systems			
COMPONENT:	Elevators	RATING: 0 x WEIGHT: 0 =	SCORE: 0
No data			
COMMENTS:			
COMPONENT:	Plumbing	RATING: 3 x WEIGHT: 8.3 =	SCORE: 25
Fixtures are functional but dated; some leaks; maintenance required			
COMMENTS:	Copper, cast iron, steel and ABS piping; porcelain fixtures		
COMPONENT:	HVAC	RATING: 3 x WEIGHT: 8.3 =	SCORE: 25
System generally adequate; some deterioration; needs balancing; Offices areas have A/C; hazardous areas are ventilated			
COMMENTS:	AHUs-steam from central plant (exchanger); air cooled chiller; rooftop packaged A/C units; no A/C in central stack area		
COMPONENT:	Electrical	RATING: 1 x WEIGHT: 8.3 =	SCORE: 8.3
Adequate service and distribution capacity for current/future needs			
COMMENTS:	450amp 208/120v; 400amp 408/277v		
COMPONENT:	Lights/Power	RATING: 1 x WEIGHT: 8.3 =	SCORE: 8.3
Contemporary lighting with good work area illumination; ample outlets			
COMMENTS:	Lay-in, recessed can and hanging circular fluorescent lighting

Safety Systems			
COMPONENT:	Life/Safety	RATING: 1 x	WEIGHT: 10.4 = SCORE: 10.4
Appears to meet current codes			
COMMENTS:			
COMPONENT:	Fire Safety	RATING: 1 x	WEIGHT: 10.4 = SCORE: 10.4
Locally monitored detection; alarm present; sprinklers in high hazard areas			
COMMENTS:			
COMPONENT:	Modifications	RATING: 3 x	WEIGHT: 7.3 = SCORE: 21.9
Some modifications lack code compliance; HVAC service not fully considered during renovation			
COMMENTS:	A/C upgrade not provided during last remodel

Quality Standards			
COMPONENT:	Maintenance	RATING: 3 x	WEIGHT: 7.3 = SCORE: 21.9
Routine maintenance is required; deferred maintenance is evident; impact is minor to moderate			
COMMENTS:			
COMPONENT:	Remaining Life	RATING: 3 x	WEIGHT: 6.3 = SCORE: 18.8
Life expectancy is 5-15 years; moderate system deterioration			
COMMENTS:	Building construction is average		
COMPONENT:	Appearance	RATING: 3 x	WEIGHT: 6.3 = SCORE: 18.8
Average construction; average interior and exterior appearance			
COMMENTS:	Exterior is very average

Heat Loss			
COMPONENT:	Insulation	RATING: 3 x	WEIGHT: 6.3 = SCORE: 18.8
Insulation present, but not to current standards (installed prior to 2010)			
COMMENTS:			
COMPONENT:	Glazing	RATING: 3 x	WEIGHT: 6.3 = SCORE: 18.8
Double glazing with aluminum/metal window frames			
COMMENTS:	Leaks at north windows

TOTAL SCORE = 321 PREVIOUS BIENNIUM SCORE = 298
 CONDITION: Needs Improvement/Additional Maintenance

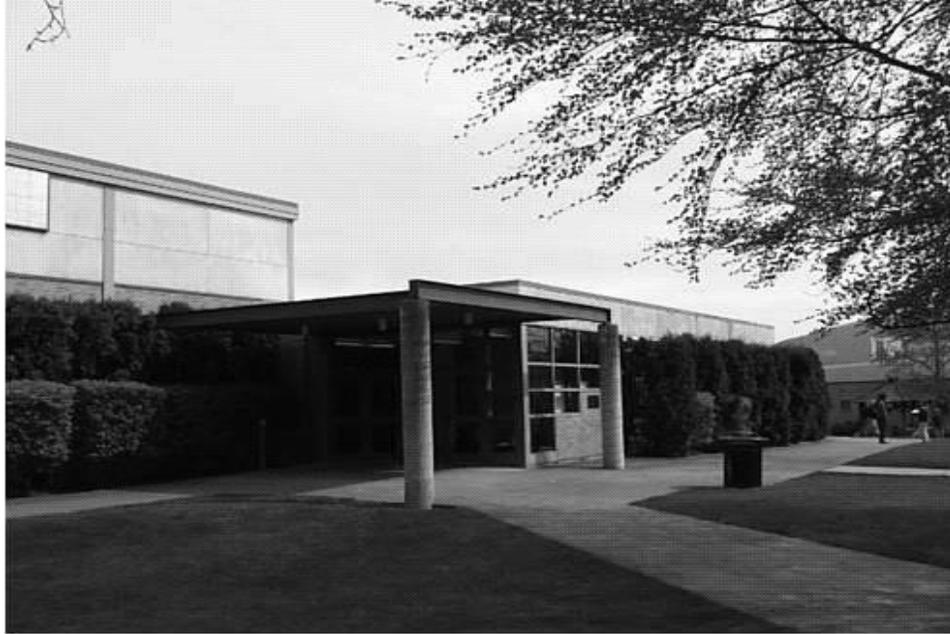
Pavilion (040-50) STATE UFI: A08558 Main Campus (040A)
 AREA: 27,252 SF BUILT: 1919 REMODELED: 2001 PREDOMINANT USE: Gymnasium
 CONSTRUCTION TYPE: Heavy CRV/SF: \$279 REPLACEMENT VALUE: \$7,603,308

Primary Systems	
COMPONENT: Structure	RATING: 1 x WEIGHT: 8 = SCORE: 8
No signs of settlement or cracking, no abrupt vertical changes Columns, bearing walls and roof structure appears sound/free of defects	
COMMENTS: Steel-frame; brick; concrete; glu-lam beams	
COMPONENT: Exterior Closure	RATING: 3 x WEIGHT: 8 = SCORE: 24
Sound and weatherproof but with some deterioration evident	
COMMENTS: Brick, stucco; west wall stucco cracked and water damage	
COMPONENT: Roofing	RATING: 1 x WEIGHT: 10 = SCORE: 10
Flashing and penetrations appear sound and membrane appears water- tight; drainage is positive and there are overflow scuppers	
COMMENTS: Single ply PVC membrane

COMPONENT:	Floor Finishes	RATING: 1	x	WEIGHT: 6	=	SCORE: 6
	Nice appearance, smooth transitions, level subfloors, no cracks/separating					
COMMENTS:	Hardwood; carpet; concrete; epoxy; linoleum; ceramic tile					
COMPONENT:	Wall Finishes	RATING: 1	x	WEIGHT: 6	=	SCORE: 6
	Maintainable surfaces in good condition					
COMMENTS:	Ceramic tile; wood panels; gypsum board; brick; CMU; carpet					
COMPONENT:	Ceiling Finishes	RATING: 1	x	WEIGHT: 6	=	SCORE: 6
	Maintainable surfaces in good condition; good alignment and appearance					
COMMENTS:	Gypsum board; exposed concrete structure; metal deck pan; direct-adhered tile					
COMPONENT:	Doors & Hardware	RATING: 3	x	WEIGHT: 6	=	SCORE: 18
	Functional but dated					
COMMENTS:	Interior wood doors w HM frames; exterior HM doors/frames-extensive surface wear; some dents

COMPONENT:	Elevators	RATING: 5	x	WEIGHT: 6	=	SCORE: 30
	No elevator access for upper floors					
COMMENTS:	1 story w/ gym mezzanine					
COMPONENT:	Plumbing	RATING: 3	x	WEIGHT: 8	=	SCORE: 24
	Fixtures are functional but dated; some leaks; maintenance required					
COMMENTS:	Galvanized, cast iron, steel, copper and PVC pipe; porcelain fixtures					
COMPONENT:	HVAC	RATING: 1	x	WEIGHT: 8	=	SCORE: 8
	Equipment in good condition; easily controlled; serves all required spaces; All necessary spaces are adequately ventilated; A/C provided					
COMMENTS:	Steam/hot water heat w fan coil units and steam radiators- fed from central plant; DX cooling; rooftop gas packs					
COMPONENT:	Electrical	RATING: 1	x	WEIGHT: 8	=	SCORE: 8
	Adequate service and distribution capacity for current/future needs					
COMMENTS:	800amp 480/277v					
COMPONENT:	Lights/Power	RATING: 1	x	WEIGHT: 8	=	SCORE: 8
	Contemporary lighting with good work area illumination; ample outlets

Safety Systems			
COMPONENT:	Life/Safety	RATING: 1 x	WEIGHT: 10 = SCORE: 10
Appears to meet current codes			
COMMENTS:			
COMPONENT:	Fire Safety	RATING: 3 x	WEIGHT: 10 = SCORE: 30
Extinguishers and signed egress; no violations; no alarm or sprinklers			
COMMENTS:			
COMPONENT:	Modifications	RATING: 1 x	WEIGHT: 7 = SCORE: 7
Modifications appear to be in compliance with codes and sound construction practices; HVAC/electrical service properly provided			
COMMENTS:	Fitness center addition appears to be in compliance with codes and sound construction

Quality Standards			
COMPONENT:	Maintenance	RATING: 1 x	WEIGHT: 7 = SCORE: 7
Facility appears well maintained			
COMMENTS:			
COMPONENT:	Remaining Life	RATING: 3 x	WEIGHT: 6 = SCORE: 18
Life expectancy is 5-15 years; moderate system deterioration			
COMMENTS:	Reasonably well-constructed building; should have 20+ yr. life		
COMPONENT:	Appearance	RATING: 3 x	WEIGHT: 6 = SCORE: 18
Average construction; average interior and exterior appearance			
COMMENTS:

TOTAL SCORE = 282 PREVIOUS BIENNIUM SCORE = 258
 CONDITION: Needs Improvement/Additional Maintenance

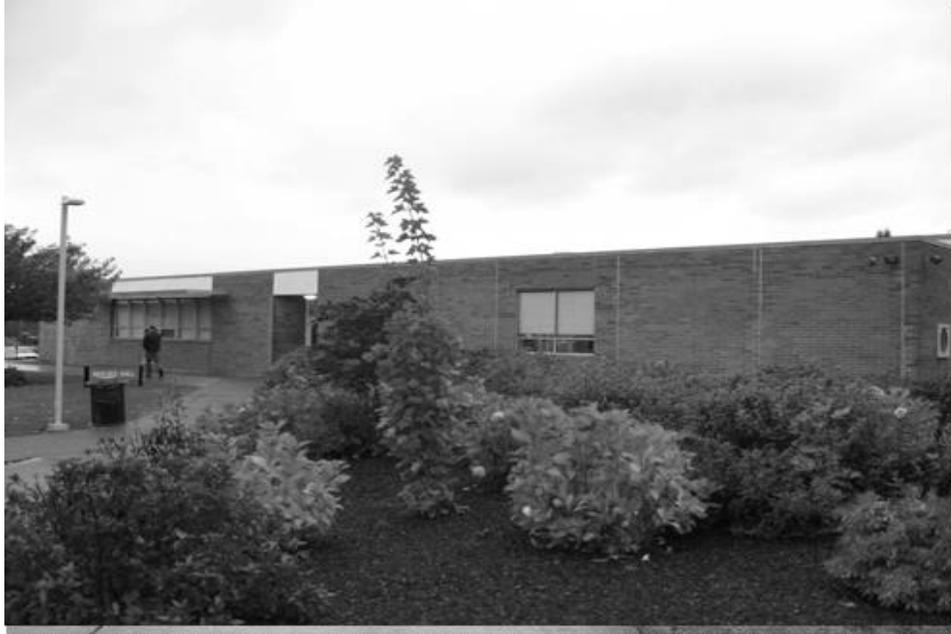
Reeves Hall (040-85) STATE UFI: A05238 Main Campus (040A)
 AREA: 21,970 SF BUILT: 1959 REMODELED: No PREDOMINANT USE: General Classroom
 CONSTRUCTION TYPE: Medium CRV/SF: \$301 REPLACEMENT VALUE: \$6,612,970

Primary Systems	
COMPONENT: Structure	RATING: 1 x WEIGHT: 8.3 = SCORE: 8.3
No signs of settlement or cracking, no abrupt vertical changes Columns, bearing walls and roof structure appears sound/free of defects	
COMMENTS: Steel columns & roof trusses; CMU	
COMPONENT: Exterior Closure	RATING: 1 x WEIGHT: 8.3 = SCORE: 8.3
Weatherproof, tight, well-maintained exterior walls, doors, windows/finishes	
COMMENTS: Brick veneer; stucco; CMU; fiberglass; metal panels; funded in 2011 for brick tuck-point	
COMPONENT: Roofing	RATING: 1 x WEIGHT: 10.4 = SCORE: 10.4
Flashing and penetrations appear sound and membrane appears water- tight; drainage is positive and there are overflow scuppers	
COMMENTS: Single-ply 2013

Secondary Systems			
COMPONENT:	Floor Finishes	RATING: 5 x WEIGHT: 6.3 =	SCORE: 31.3
Extensive deterioration and unevenness			
COMMENTS:	Vinyl asbestos tile, carpet, concrete; ceramic tile		
COMPONENT:	Wall Finishes	RATING: 3 x WEIGHT: 6.3 =	SCORE: 18.8
Aging surfaces but sound; some maintenance is required			
COMMENTS:	Gypsum board; plaster; tectum panels; CMU; plywood; ceramic tile; brick		
COMPONENT:	Ceiling Finishes	RATING: 5 x WEIGHT: 6.3 =	SCORE: 31.3
Deteriorated, significant number of stained or sagging areas; inappropriate for occupancy			
COMMENTS:	Lay-in tile; gypsum board; metal deck pan		
COMPONENT:	Doors & Hardware	RATING: 5 x WEIGHT: 6.3 =	SCORE: 31.3
Inoperable, deteriorating and outdated; non-secure			
COMMENTS:	Interior wood doors w HM frames; exterior HM doors/frames; OH metal doors

Service Systems			
COMPONENT:	Elevators	RATING: 0 x WEIGHT: 0 =	SCORE: 0
No data			
COMMENTS:			
COMPONENT:	Plumbing	RATING: 5 x WEIGHT: 8.3 =	SCORE: 41.7
Extensive pipe leaks or blockage; deteriorated fixtures; inadequate fixtures			
COMMENTS:	Galvanized, cast iron and steel piping; porcelain fixtures		
COMPONENT:	HVAC	RATING: 5 x WEIGHT: 8.3 =	SCORE: 41.7
Inadequate capacity, zoning and distribution; equipment deteriorating; No A/C in office areas; no ventilation in hazardous areas			
COMMENTS:	HW unit ventilators-fed from central plant, make-up air unit; unit heaters		
COMPONENT:	Electrical	RATING: 5 x WEIGHT: 8.3 =	SCORE: 41.7
Loads exceed current capacity			
COMMENTS:	600amp 480/277v		
COMPONENT:	Lights/Power	RATING: 3 x WEIGHT: 8.3 =	SCORE: 25
Adequate work area illumination; adequate outlets for current use			
COMMENTS:	Hanging, ceiling-mount and lay-in fluorescent fixtures

Safety Systems			
COMPONENT:	Life/Safety	RATING: 3 x	WEIGHT: 10.4 = SCORE: 31.3
Generally meets codes for vintage of construction			
COMMENTS:			
COMPONENT:	Fire Safety	RATING: 3 x	WEIGHT: 10.4 = SCORE: 31.3
Extinguishers and signed egress; no violations; no alarm or sprinklers			
COMMENTS:			
COMPONENT:	Modifications	RATING: 1 x	WEIGHT: 7.3 = SCORE: 7.3
Modifications appear to be in compliance with codes and sound construction practices; HVAC/electrical service properly provided			
COMMENTS:	Few modifications to present

Quality Standards			
COMPONENT:	Maintenance	RATING: 3 x	WEIGHT: 7.3 = SCORE: 21.9
Routine maintenance is required; deferred maintenance is evident; impact is minor to moderate			
COMMENTS:			
COMPONENT:	Remaining Life	RATING: 3 x	WEIGHT: 6.3 = SCORE: 18.8
Life expectancy is 5-15 years; moderate system deterioration			
COMMENTS:	Many system upgrades in 2011-13		
COMPONENT:	Appearance	RATING: 5 x	WEIGHT: 6.3 = SCORE: 31.3
Poor to average construction, but very unattractive exterior and interior spaces			
COMMENTS:

Heat Loss			
COMPONENT:	Insulation	RATING: 3 x	WEIGHT: 6.3 = SCORE: 18.8
Insulation present, but not to current standards (installed prior to 2010)			
COMMENTS:			
COMPONENT:	Glazing	RATING: 3 x	WEIGHT: 6.3 = SCORE: 18.8
Double glazing with aluminum/metal window frames			
COMMENTS:	Most windows replaced in 2011-13

TOTAL SCORE = 469 PREVIOUS BIENNIUM SCORE = 484
 CONDITION: Needs Improvement/Renovation

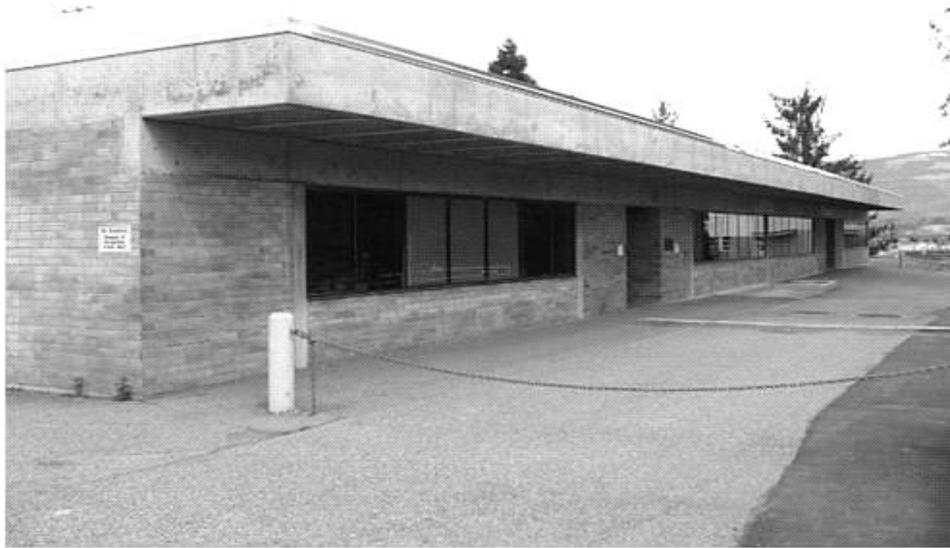
Roberts Hall (040-80) STATE UFI: A09398 Main Campus (040A)
 AREA: 33,281 SF BUILT: 1971 REMODELED: No PREDOMINANT USE: Vocational Arts
 CONSTRUCTION TYPE: Heavy CRV/SF: \$316 REPLACEMENT VALUE: \$10,516,796

Primary Systems	
COMPONENT: Structure	RATING: 1 x WEIGHT: 8.3 = SCORE: 8.3
No signs of settlement or cracking, no abrupt vertical changes Columns, bearing walls and roof structure appears sound/free of defects	
COMMENTS: Structural brick; concrete	
COMPONENT: Exterior Closure	RATING: 1 x WEIGHT: 8.3 = SCORE: 8.3
Weatherproof, tight, well-maintained exterior walls, doors, windows/finishes	
COMMENTS: Brick; concrete	
COMPONENT: Roofing	RATING: 1 x WEIGHT: 10.4 = SCORE: 10.4
Flashing and penetrations appear sound and membrane appears water- tight; drainage is positive and there are overflow scuppers	
COMMENTS: Ballasted PVC single-ply membrane-2003

Secondary Systems			
COMPONENT:	Floor Finishes	RATING: 3 x	WEIGHT: 6.3 = SCORE: 18.8
	Some wear and minor imperfections are evident; beginning deterioration		
COMMENTS:	Concrete; sheet vinyl; carpet; epoxy flooring		
COMPONENT:	Wall Finishes	RATING: 3 x	WEIGHT: 6.3 = SCORE: 18.8
	Aging surfaces but sound; some maintenance is required		
COMMENTS:	Exposed brick walls; gypsum board; ceramic tile		
COMPONENT:	Ceiling Finishes	RATING: 3 x	WEIGHT: 6.3 = SCORE: 18.8
	Some wear and tear; Minor staining or deterioration		
COMMENTS:	Concrete; lay-in tile; direct-adhered tile		
COMPONENT:	Doors & Hardware	RATING: 3 x	WEIGHT: 6.3 = SCORE: 18.8
	Functional but dated		
COMMENTS:	Interior HM doors/frames; exterior HM doors/frames; glazed metal OH doors

Service Systems			
COMPONENT:	Elevators	RATING: 0 x	WEIGHT: 0 = SCORE: 0
	No data		
COMMENTS:			
COMPONENT:	Plumbing	RATING: 3 x	WEIGHT: 8.3 = SCORE: 25
	Fixtures are functional but dated; some leaks; maintenance required		
COMMENTS:	Copper, cast iron, steel and PVC piping; porcelain fixtures		
COMPONENT:	HVAC	RATING: 3 x	WEIGHT: 8.3 = SCORE: 25
	System generally adequate; some deterioration; needs balancing; Offices areas have A/C; hazardous areas are ventilated		
COMMENTS:	Constant volume AHU w/reheat; air-cooled chiller; unit heaters in shops; (2) CRAC units		
COMPONENT:	Electrical	RATING: 1 x	WEIGHT: 8.3 = SCORE: 8.3
	Adequate service and distribution capacity for current/future needs		
COMMENTS:	1600amp 480/277v; 150kw emergency generator		
COMPONENT:	Lights/Power	RATING: 1 x	WEIGHT: 8.3 = SCORE: 8.3
	Contemporary lighting with good work area illumination; ample outlets		
COMMENTS:	Lay-in, wall-mount, ceiling-mount and hanging strip fluorescent fixtures; 2012 ESCO upgrades

Safety Systems			
COMPONENT:	Life/Safety	RATING: 3 x	WEIGHT: 10.4 = SCORE: 31.3
Generally meets codes for vintage of construction			
COMMENTS:			
COMPONENT:	Fire Safety	RATING: 1 x	WEIGHT: 10.4 = SCORE: 10.4
Locally monitored detection; alarm present; sprinklers in high hazard areas			
COMMENTS:	Sprinklers in all shop areas		
COMPONENT:	Modifications	RATING: 3 x	WEIGHT: 7.3 = SCORE: 21.9
Some modifications lack code compliance; HVAC service not fully considered during renovation			
COMMENTS:

Quality Standards			
COMPONENT:	Maintenance	RATING: 1 x	WEIGHT: 7.3 = SCORE: 7.3
Facility appears well maintained			
COMMENTS:			
COMPONENT:	Remaining Life	RATING: 3 x	WEIGHT: 6.3 = SCORE: 18.8
Life expectancy is 5-15 years; moderate system deterioration			
COMMENTS:			
COMPONENT:	Appearance	RATING: 3 x	WEIGHT: 6.3 = SCORE: 18.8
Average construction; average interior and exterior appearance			
COMMENTS:	Exterior is very spartan; not attractive

TOTAL SCORE = 327 PREVIOUS BIENNIUM SCORE = 292
 CONDITION: Needs Improvement/Additional Maintenance
