2015 FACILITY CONDITION SURVEY

Skagit Valley College

SURVEY CONDUCTED BY:
Steve Lewandowski
State Board for Community
and Technical Colleges

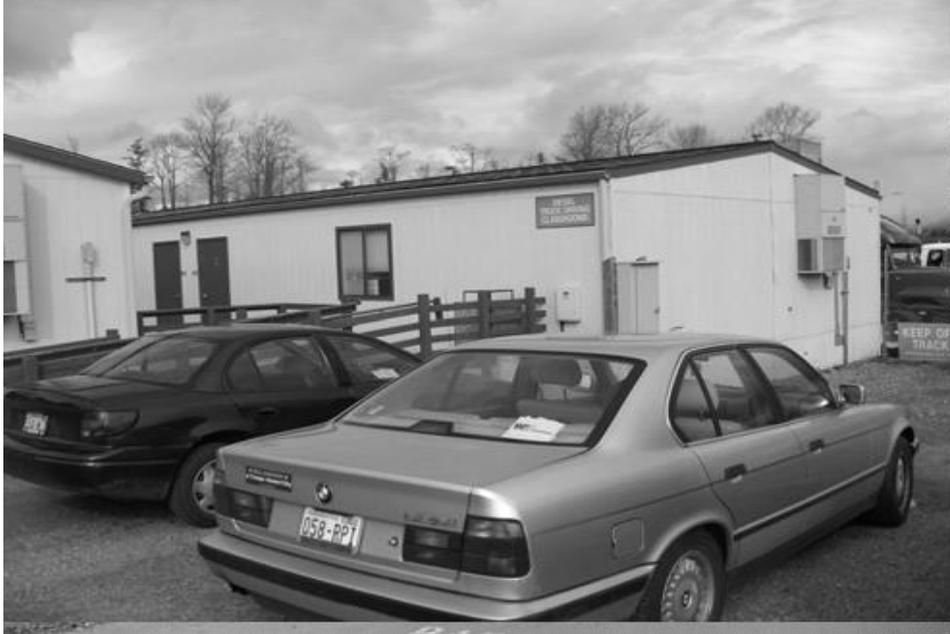
Truck Driver Classroom (040-87) STATE UFI: A02266 Main Campus (040A)
 AREA: 1,792 SF BUILT: No data REMODELED: No PREDOMINANT USE: General Classroom
 CONSTRUCTION TYPE: Temporary CRV/SF: \$158 REPLACEMENT VALUE: \$283,136

Primary Systems		
COMPONENT:	Structure	RATING: 5 x WEIGHT: 8.8 = SCORE: 44.2
Visible settlement and potential structural failure; potential safety hazard Structural defects apparent in superstructure		
COMMENTS:	Two manufactured portables w/connecting wood deck between	
COMPONENT:	Exterior Closure	RATING: 5 x WEIGHT: 8.8 = SCORE: 44.2
Significant deterioration, leaking and air infiltration apparent		
COMMENTS:	T1-11	
COMPONENT:	Roofing	RATING: 3 x WEIGHT: 11.1 = SCORE: 33.2
Some deterioration is evident in membrane and flashings; maintenance or minor repair is needed		
COMMENTS:	Composition shingle

Secondary Systems			
COMPONENT:	Floor Finishes	RATING: 5 x WEIGHT: 6.6 =	SCORE: 33.2
Extensive deterioration and unevenness			
COMMENTS:	Vinyl tile		
COMPONENT:	Wall Finishes	RATING: 5 x WEIGHT: 6.6 =	SCORE: 33.2
Surfaces are deteriorated and require resurfacing or rebuilding			
COMMENTS:	Vinyl panels		
COMPONENT:	Ceiling Finishes	RATING: 5 x WEIGHT: 6.6 =	SCORE: 33.2
Deteriorated, significant number of stained or sagging areas; inappropriate for occupancy			
COMMENTS:	Lay-in tile		
COMPONENT:	Doors & Hardware	RATING: 5 x WEIGHT: 6.6 =	SCORE: 33.2
Inoperable, deteriorating and outdated; non-secure			
COMMENTS:	Lay-in fluorescent. fixtures

Service Systems			
COMPONENT:	Elevators	RATING: 0 x WEIGHT: 0 =	SCORE: 0
No data			
COMMENTS:			
COMPONENT:	Plumbing	RATING: 0 x WEIGHT: 0 =	SCORE: 0
No data			
COMMENTS:	None		
COMPONENT:	HVAC	RATING: 3 x WEIGHT: 8.8 =	SCORE: 26.5
System generally adequate; some deterioration; needs balancing; Offices areas have A/C; hazardous areas are ventilated			
COMMENTS:	Wall mounted heat pump		
COMPONENT:	Electrical	RATING: 3 x WEIGHT: 8.8 =	SCORE: 26.5
Service capacity meets current needs but inadequate for future			
COMMENTS:	200amp 208/120v		
COMPONENT:	Lights/Power	RATING: 3 x WEIGHT: 8.8 =	SCORE: 26.5
Adequate work area illumination; adequate outlets for current use			
COMMENTS:	Lay-in fluorescent lights

Safety Systems			
COMPONENT:	Life/Safety	RATING: 5 x	WEIGHT: 11.1 = SCORE: 55.3
Does not meet minimum health/safety requirements			
COMMENTS:			
COMPONENT:	Fire Safety	RATING: 5 x	WEIGHT: 11.1 = SCORE: 55.3
Violations exist; No exit signs or extinguishers; No sprinklers in high hazard areas			
COMMENTS:			
COMPONENT:	Modifications	RATING: 1 x	WEIGHT: 7.7 = SCORE: 7.7
Modifications appear to be in compliance with codes and sound construction practices; HVAC/electrical service properly provided			
COMMENTS: Few modifications to present

Quality Standards			
COMPONENT:	Maintenance	RATING: 5 x	WEIGHT: 7.7 = SCORE: 38.7
General deterioration is evident; lack of adequate maintenance is evident; impact is moderate to severe			
COMMENTS:			
COMPONENT:	Remaining Life	RATING: 5 x	WEIGHT: 6.6 = SCORE: 33.2
Life expectancy is <5 years; significant system deterioration			
COMMENTS: NO LONGER NEEDED BY COLLEGE; WILL BE DEMOLISHED			
COMPONENT:	Appearance	RATING: 5 x	WEIGHT: 6.6 = SCORE: 33.2
Poor to average construction, but very unattractive exterior and interior spaces			
COMMENTS:

TOTAL SCORE = 597 PREVIOUS BIENNIUM SCORE = 506
 CONDITION: Replace or Renovate

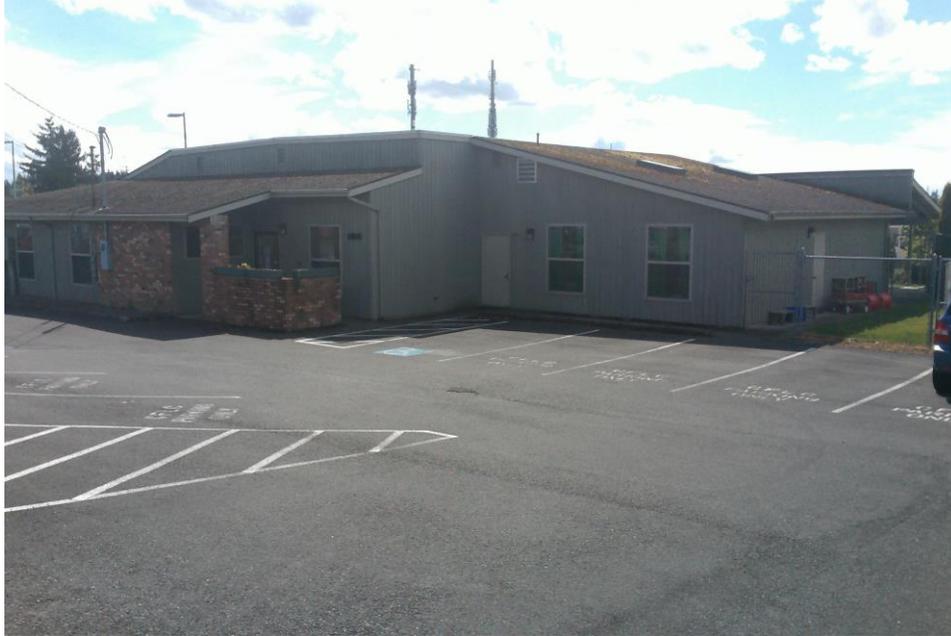
Child & Family Learning Center (040-42) STATE UFI: A03753 Main Campus (040A)
 AREA: 4,792 SF BUILT: 1986 REMODELED: No data PREDOMINANT USE:
 CONSTRUCTION TYPE: No data CRV/SF: \$0 REPLACEMENT VALUE: \$4792

Primary Systems	
COMPONENT: Structure	RATING: 1 x WEIGHT: 8.3 = SCORE: 8.3
No signs of settlement or cracking, no abrupt vertical changes Columns, bearing walls and roof structure appears sound/free of defects	
COMMENTS: No data	
COMPONENT: Exterior Closure	RATING: 3 x WEIGHT: 8.3 = SCORE: 25
Sound and weatherproof but with some deterioration evident	
COMMENTS: No data	
COMPONENT: Roofing	RATING: 3 x WEIGHT: 10.4 = SCORE: 31.3
Some deterioration is evident in membrane and flashings; maintenance or minor repair is needed	
COMMENTS: comp shingles 2001

COMPONENT:	Floor Finishes	RATING: 3	x	WEIGHT: 6.3	=	SCORE: 18.8
Some wear and minor imperfections are evident; beginning deterioration						
COMMENTS:	No data					
COMPONENT:	Wall Finishes	RATING: 3	x	WEIGHT: 6.3	=	SCORE: 18.8
Aging surfaces but sound; some maintenance is required						
COMMENTS:	No data					
COMPONENT:	Ceiling Finishes	RATING: 3	x	WEIGHT: 6.3	=	SCORE: 18.8
Some wear and tear; Minor staining or deterioration						
COMMENTS:	No data					
COMPONENT:	Doors & Hardware	RATING: 1	x	WEIGHT: 6.3	=	SCORE: 6.3
Appropriate hardware, closers, panic devices; in good working order						
COMMENTS:	No data

COMPONENT:	Elevators	RATING: 0	x	WEIGHT: 0	=	SCORE: 0
No data						
COMMENTS:	No data					
COMPONENT:	Plumbing	RATING: 1	x	WEIGHT: 8.3	=	SCORE: 8.3
Fixtures and piping appear to be in good condition; no evidence of leaks						
COMMENTS:	No data					
COMPONENT:	HVAC	RATING: 1	x	WEIGHT: 8.3	=	SCORE: 8.3
Equipment in good condition; easily controlled; serves all required spaces; All necessary spaces are adequately ventilated; A/C provided						
COMMENTS:	No data					
COMPONENT:	Electrical	RATING: 1	x	WEIGHT: 8.3	=	SCORE: 8.3
Adequate service and distribution capacity for current/future needs						
COMMENTS:	No data					
COMPONENT:	Lights/Power	RATING: 1	x	WEIGHT: 8.3	=	SCORE: 8.3
Contemporary lighting with good work area illumination; ample outlets						
COMMENTS:	No data

Safety Systems			
COMPONENT:	Life/Safety	RATING: 1 x	WEIGHT: 10.4 = SCORE: 10.4
	Appears to meet current codes		
COMMENTS:	No data		
COMPONENT:	Fire Safety	RATING: 3 x	WEIGHT: 10.4 = SCORE: 31.3
	Extinguishers and signed egress; no violations; no alarm or sprinklers		
COMMENTS:	No data		
COMPONENT:	Modifications	RATING: 1 x	WEIGHT: 7.3 = SCORE: 7.3
	Modifications appear to be in compliance with codes and sound construction practices; HVAC/electrical service properly provided		
COMMENTS:	No data

Quality Standards			
COMPONENT:	Maintenance	RATING: 1 x	WEIGHT: 7.3 = SCORE: 7.3
	Facility appears well maintained		
COMMENTS:	No data		
COMPONENT:	Remaining Life	RATING: 1 x	WEIGHT: 6.3 = SCORE: 6.3
	Life expectancy is >15 years; minor system deterioration		
COMMENTS:	No data		
COMPONENT:	Appearance	RATING: 3 x	WEIGHT: 6.3 = SCORE: 18.8
	Average construction; average interior and exterior appearance		
COMMENTS:	No data

TOTAL SCORE = 267 PREVIOUS BIENNIUM SCORE = (blank)
 CONDITION: Adequate

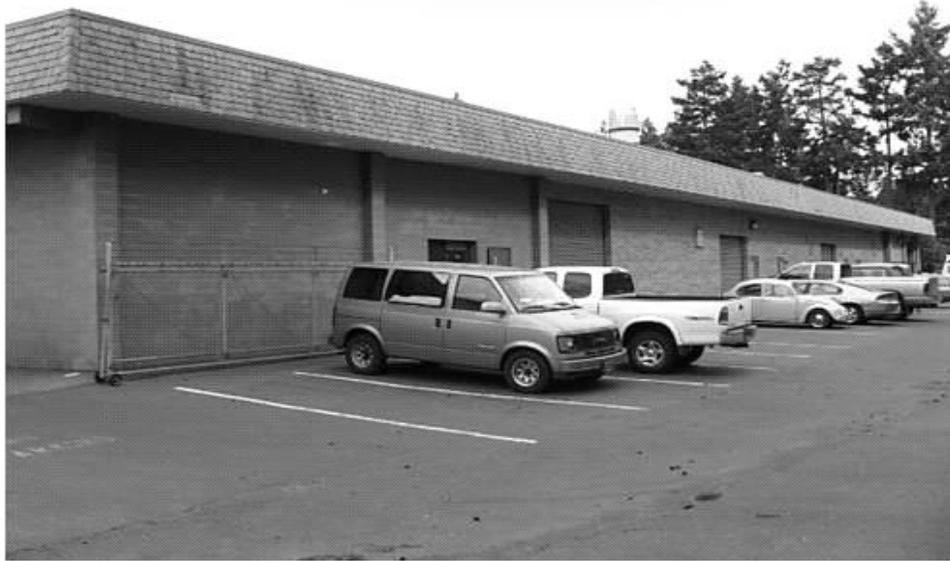
Whidbey Marine Tech (040-13) STATE UFI: A02457 Marine Technology Site (040E)
 AREA: 12,720 SF BUILT: 1905 REMODELED: No PREDOMINANT USE: Vocational Arts
 CONSTRUCTION TYPE: Medium CRV/SF: \$316 REPLACEMENT VALUE: \$4,019,520

Primary Systems	
COMPONENT: Structure	RATING: 1 x WEIGHT: 8.3 = SCORE: 8.3
No signs of settlement or cracking, no abrupt vertical changes Columns, bearing walls and roof structure appears sound/free of defects	
COMMENTS:	Structural brick; CMU; steel roof trusses
COMPONENT: Exterior Closure	RATING: 1 x WEIGHT: 8.3 = SCORE: 8.3
Weatherproof, tight, well-maintained exterior walls, doors, windows/finishes	
COMMENTS:	Brick; CMU for addition (infill); exterior gypsum board soffits
COMPONENT: Roofing	RATING: 3 x WEIGHT: 10.4 = SCORE: 31.3
Some deterioration is evident in membrane and flashings; maintenance or minor repair is needed	
COMMENTS:	Hypalon single-ply membrane roof- deteriorating; composition shingles at mansards

Secondary Systems			
COMPONENT:	Floor Finishes	RATING: 1 x WEIGHT: 6.3 =	SCORE: 6.3
Nice appearance, smooth transitions, level subfloors, no cracks/separating			
COMMENTS:	Concrete; vinyl tile		
COMPONENT:	Wall Finishes	RATING: 1 x WEIGHT: 6.3 =	SCORE: 6.3
Maintainable surfaces in good condition			
COMMENTS:	Brick, CMU, gypsum board		
COMPONENT:	Ceiling Finishes	RATING: 3 x WEIGHT: 6.3 =	SCORE: 18.8
Some wear and tear; Minor staining or deterioration			
COMMENTS:	Lay-in tile; gypsum board		
COMPONENT:	Doors & Hardware	RATING: 1 x WEIGHT: 6.3 =	SCORE: 6.3
Appropriate hardware, closers, panic devices; in good working order			
COMMENTS:	Interior/exterior H doors/frames; OH metal doors-2002

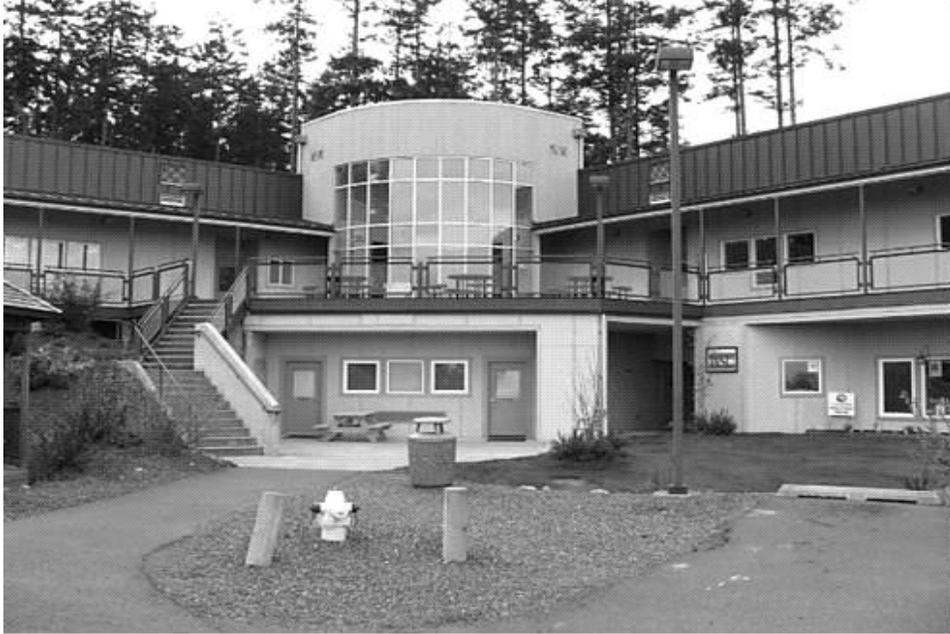
San Juan Center (040-89) STATE UFI: A04979 San Juan Center (040H)
 AREA: 7,710 SF BUILT: 1996 REMODELED: No PREDOMINANT USE: General Classroom
 CONSTRUCTION TYPE: Light CRV/SF: \$295 REPLACEMENT VALUE: \$2,274,450

Primary Systems	
COMPONENT: Structure	RATING: 3 x WEIGHT: 8 = SCORE: 24
Some cracking evident but does not likely affect structural integrity; Visible defects apparent but are non-structural	
COMMENTS: Stepped foundation; Wood frame	
COMPONENT: Exterior Closure	RATING: 1 x WEIGHT: 8 = SCORE: 8
Weatherproof, tight, well-maintained exterior walls, doors, windows/finishes	
COMMENTS: Wood panels & battens; vertical cedar siding; standing seam metal panels; concrete	
COMPONENT: Roofing	RATING: 3 x WEIGHT: 10 = SCORE: 30
Some deterioration is evident in membrane and flashings; maintenance or minor repair is needed	
COMMENTS: Standing seam metal panels; hypalon single ply-deteriorated. Will be replaced summer 2015

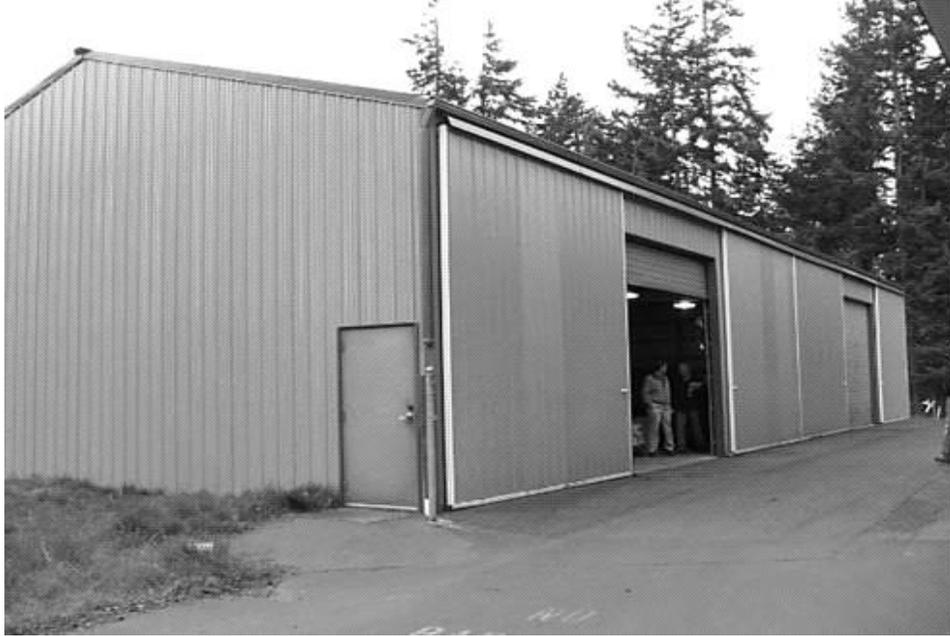
Marine Tech Strg Bldg (040-14) STATE UFI: A06375 Whidbey Campus (040C)
 AREA: 3,024 SF BUILT: 1995 REMODELED: No PREDOMINANT USE: Storage
 CONSTRUCTION TYPE: Light CRV/SF: \$185 REPLACEMENT VALUE: \$559,440

Primary Systems	
COMPONENT: Structure	RATING: 1 x WEIGHT: 9.9 = SCORE: 9.9
No signs of settlement or cracking, no abrupt vertical changes Columns, bearing walls and roof structure appears sound/free of defects	
COMMENTS: Pole building; wood framed	
COMPONENT: Exterior Closure	RATING: 1 x WEIGHT: 9.9 = SCORE: 9.9
Weatherproof, tight, well-maintained exterior walls, doors, windows/finishes	
COMMENTS: Corrugated metal panels	
COMPONENT: Roofing	RATING: 1 x WEIGHT: 12.4 = SCORE: 12.4
Flashing and penetrations appear sound and membrane appears water- tight; drainage is positive and there are overflow scuppers	
COMMENTS: Corrugated metal panels

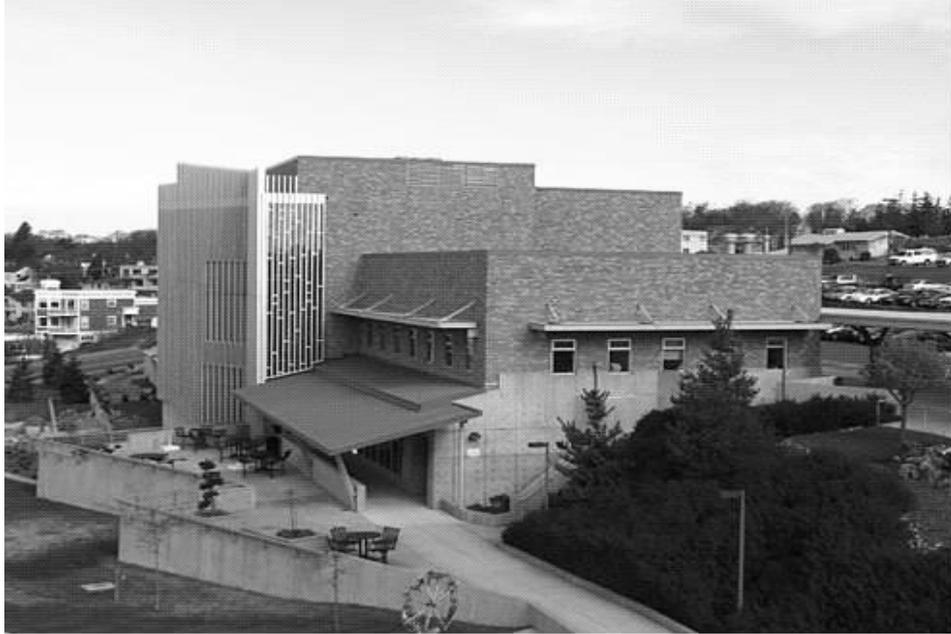
Oak Hall (040-16) STATE UFI: A03072 Whidbey Campus (040C)
 AREA: 40,725 SF BUILT: 2001 REMODELED: No PREDOMINANT USE: Multi-use
 CONSTRUCTION TYPE: Heavy CRV/SF: \$316 REPLACEMENT VALUE: \$12,869,100

Primary Systems	
COMPONENT: Structure	RATING: 1 x WEIGHT: 8 = SCORE: 8
No signs of settlement or cracking, no abrupt vertical changes Columns, bearing walls and roof structure appears sound/free of defects	
COMMENTS: Concrete; steel frame	
COMPONENT: Exterior Closure	RATING: 1 x WEIGHT: 8 = SCORE: 8
Weatherproof, tight, well-maintained exterior walls, doors, windows/finishes	
COMMENTS: Concrete; brick veneer; aluminum curtain wall	
COMPONENT: Roofing	RATING: 1 x WEIGHT: 10 = SCORE: 10
Flashing and penetrations appear sound and membrane appears water- tight; drainage is positive and there are overflow scuppers	
COMMENTS: Standing seam metal; EPDM at mechanical wells

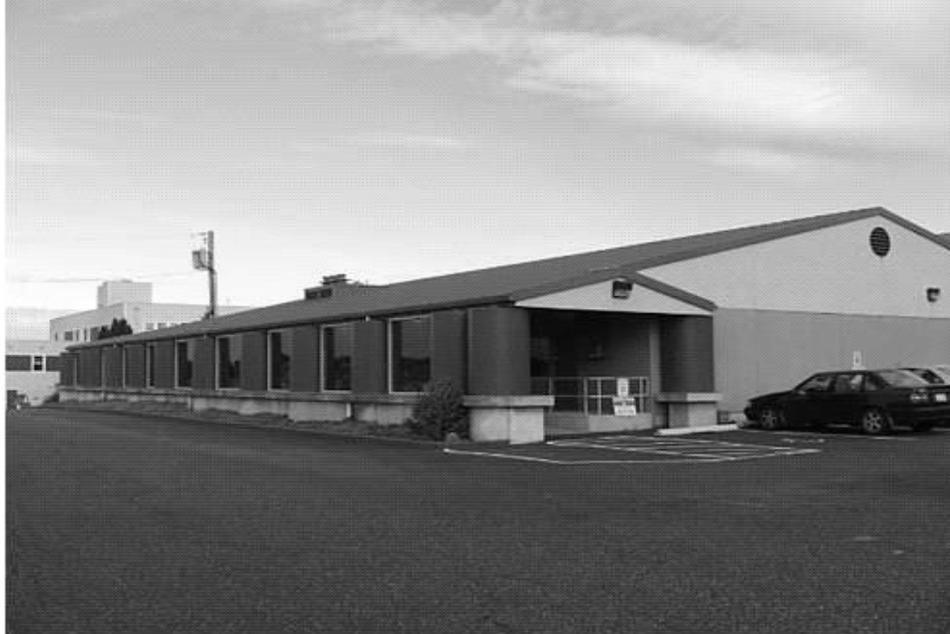
Sprague Hall (040-15) STATE UFI: A01220 Whidbey Campus (040C)
 AREA: 6,048 SF BUILT: 1905 REMODELED: No PREDOMINANT USE: General Classroom
 CONSTRUCTION TYPE: Temporary CRV/SF: \$301 REPLACEMENT VALUE: \$1,820,448

Primary Systems	
COMPONENT: Structure	RATING: 3 x WEIGHT: 8.3 = SCORE: 25
Some cracking evident but does not likely affect structural integrity; Visible defects apparent but are non-structural	
COMMENTS: Wood framed roof structure over six portables originally from Boeing	
COMPONENT: Exterior Closure	RATING: 3 x WEIGHT: 8.3 = SCORE: 25
Sound and weatherproof but with some deterioration evident	
COMMENTS: EIFS; portable metal cladding; large sheet metal columns and aluminum window wall on south	
COMPONENT: Roofing	RATING: 1 x WEIGHT: 10.4 = SCORE: 10.4
Flashing and penetrations appear sound and membrane appears water- tight; drainage is positive and there are overflow scuppers	
COMMENTS: Standing seam metal

Secondary Systems			
COMPONENT:	Floor Finishes	RATING: 3 x WEIGHT: 6.3 =	SCORE: 18.8
Some wear and minor imperfections are evident; beginning deterioration			
COMMENTS:	Vinyl tile; carpet-general surface wear		
COMPONENT:	Wall Finishes	RATING: 3 x WEIGHT: 6.3 =	SCORE: 18.8
Aging surfaces but sound; some maintenance is required			
COMMENTS:	Gypsum board-marred/dinged; vinyl panels		
COMPONENT:	Ceiling Finishes	RATING: 5 x WEIGHT: 6.3 =	SCORE: 31.3
Deteriorated, significant number of stained or sagging areas; inappropriate for occupancy			
COMMENTS:	Lay-in tiles		
COMPONENT:	Doors & Hardware	RATING: 3 x WEIGHT: 6.3 =	SCORE: 18.8
Functional but dated			
COMMENTS:	Interior wood doors/frames; exterior HM doors/frames; general surface wear

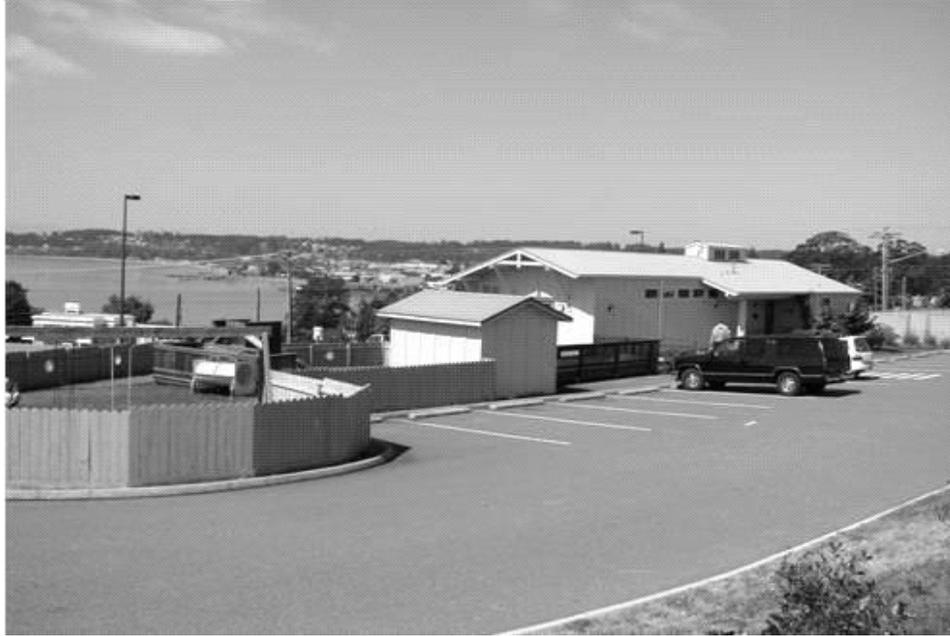
Whidbey Child Care Center (040-19) STATE UFI: A03782 Whidbey Campus (040C)
 AREA: 3,207 SF BUILT: 1991 REMODELED: No PREDOMINANT USE: Child Care/ Early Learning
 CONSTRUCTION TYPE: Light CRV/SF: \$211 REPLACEMENT VALUE: \$676,677

Primary Systems	
COMPONENT: Structure	RATING: 1 x WEIGHT: 8 = SCORE: 8
No signs of settlement or cracking, no abrupt vertical changes Columns, bearing walls and roof structure appears sound/free of defects	
COMMENTS: wood frame	
COMPONENT: Exterior Closure	RATING: 1 x WEIGHT: 8 = SCORE: 8
Weatherproof, tight, well-maintained exterior walls, doors, windows/finishes	
COMMENTS: Plywood and wood battens	
COMPONENT: Roofing	RATING: 1 x WEIGHT: 10 = SCORE: 10
Flashing and penetrations appear sound and membrane appears water- tight; drainage is positive and there are overflow scuppers	
COMMENTS: Corrugated metal

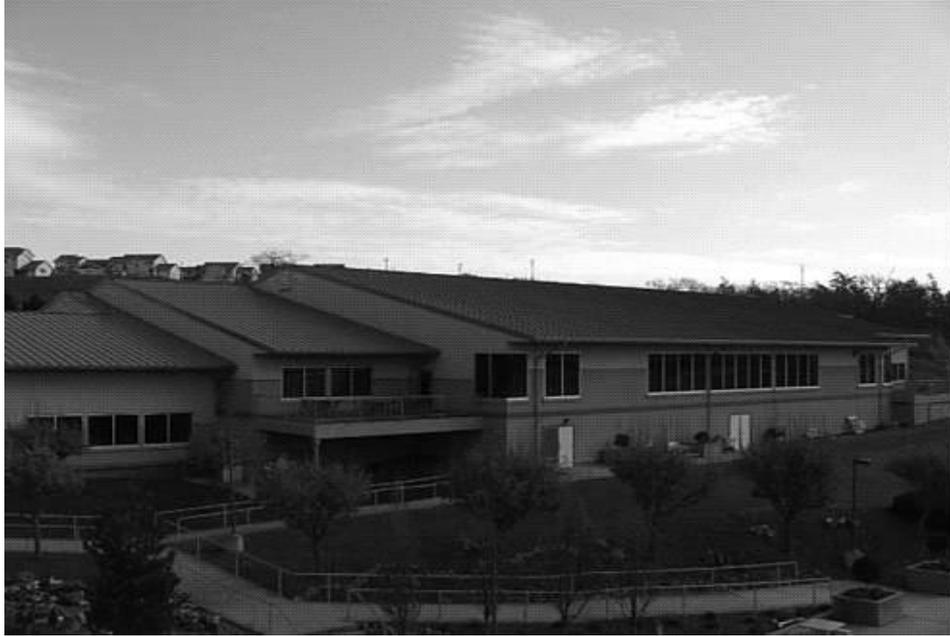
Whidbey Hayes Hall (040-18) STATE UFI: A09219 Whidbey Campus (040C)
 AREA: 15,562 SF BUILT: 1993 REMODELED: No PREDOMINANT USE: Multi-Use
 CONSTRUCTION TYPE: Medium CRV/SF: \$316 REPLACEMENT VALUE: \$4,917,592

Primary Systems	
COMPONENT: Structure	RATING: 1 x WEIGHT: 8.3 = SCORE: 8.3
No signs of settlement or cracking, no abrupt vertical changes Columns, bearing walls and roof structure appears sound/free of defects	
COMMENTS: Wood frame, roof trusses	
COMPONENT: Exterior Closure	RATING: 1 x WEIGHT: 8.3 = SCORE: 8.3
Weatherproof, tight, well-maintained exterior walls, doors, windows/finishes	
COMMENTS: EIFS	
COMPONENT: Roofing	RATING: 1 x WEIGHT: 10.4 = SCORE: 10.4
Flashing and penetrations appear sound and membrane appears water- tight; drainage is positive and there are overflow scuppers	
COMMENTS: Standing seam metal

Secondary Systems			
COMPONENT:	Floor Finishes	RATING: 3 x WEIGHT: 6.3 =	SCORE: 18.8
Some wear and minor imperfections are evident; beginning deterioration			
COMMENTS:	Strip vinyl; carpet-surface wear; ceramic tile		
COMPONENT:	Wall Finishes	RATING: 1 x WEIGHT: 6.3 =	SCORE: 6.3
Maintainable surfaces in good condition			
COMMENTS:	Gypsum board, ceramic tile		
COMPONENT:	Ceiling Finishes	RATING: 1 x WEIGHT: 6.3 =	SCORE: 6.3
Maintainable surfaces in good condition; good alignment and appearance			
COMMENTS:	Gypsum board; lay-in tile		
COMPONENT:	Doors & Hardware	RATING: 3 x WEIGHT: 6.3 =	SCORE: 18.8
Functional but dated			
COMMENTS:	Interior wood doors/frames-surface wear; exterior aluminum/wood entry doors/frames

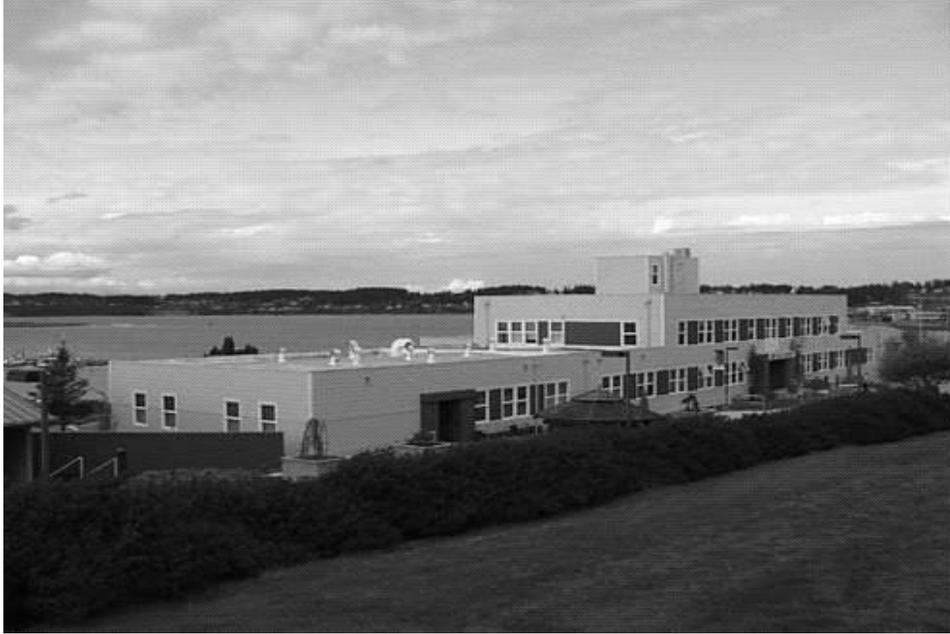
Whidbey Old Main (040-11) STATE UFI: A06127 Whidbey Campus (040C)
 AREA: 27,342 SF BUILT: 1905 REMODELED: 2003 PREDOMINANT USE: Administration
 CONSTRUCTION TYPE: Medium CRV/SF: \$301 REPLACEMENT VALUE: \$8,229,942

Primary Systems		
COMPONENT:	Structure	RATING: 3 x WEIGHT: 8 = SCORE: 24
Some cracking evident but does not likely affect structural integrity; Visible defects apparent but are non-structural		
COMMENTS:	Wood frame, CMU boiler house; possible seismic issues	
COMPONENT:	Exterior Closure	RATING: 3 x WEIGHT: 8 = SCORE: 24
Sound and weatherproof but with some deterioration evident		
COMMENTS:	Hardboard beveled siding-2003	
COMPONENT:	Roofing	RATING: 5 x WEIGHT: 10 = SCORE: 50
Leaking and deterioration is to point where new roof is required		
COMMENTS:	Hypalon single-ply; some patches and random surface wear
